TIER 1 SEISMIC EVALUATION
Immediate Occupancy Structural Performance Level
Campbell City Hall
Campbell, California

Draft Report

August 22, 2017

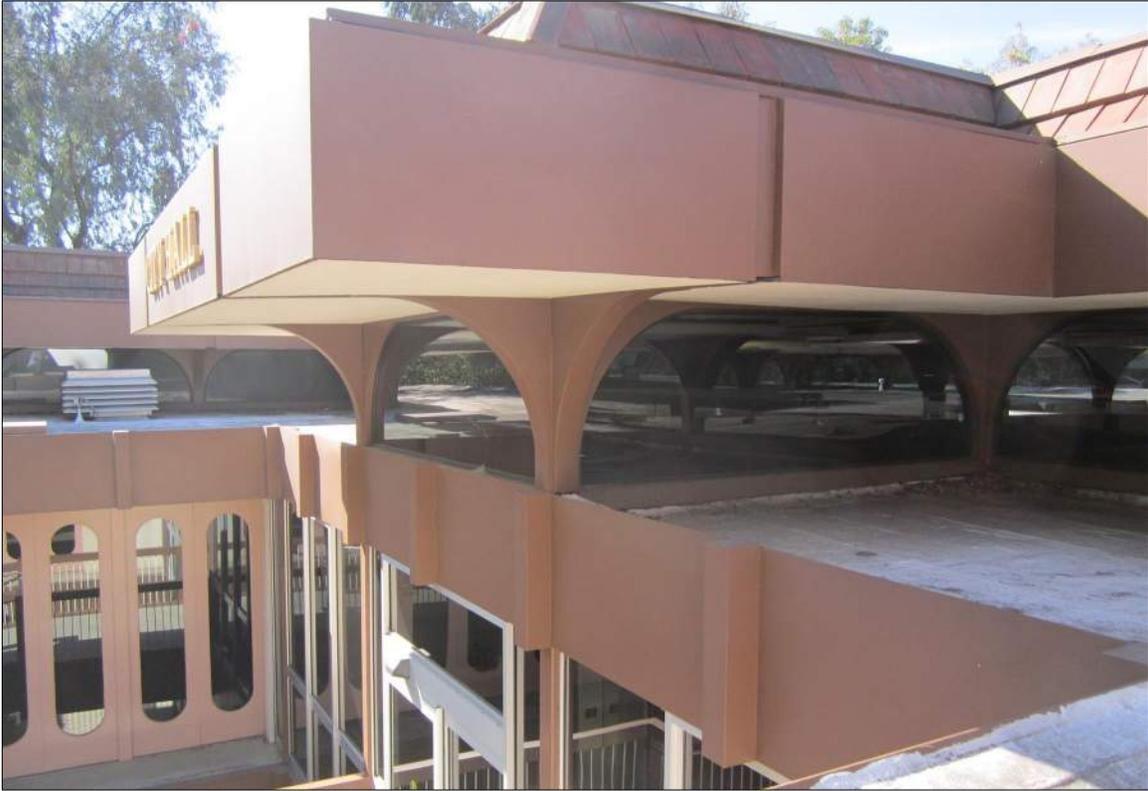
At the high roof of the City Hall, the plywood roof diaphragm transfers lateral forces through the steel cantilevered columns into the lower roof diaphragm. At second story the plywood roof diaphragm transfers lateral forces into the perimeter plywood shear walls. At the first story, the plywood second floor diaphragm transfers lateral forces into the masonry shear walls at perimeter of the building. The forces from the second-story plywood shear walls are transferred directly into the first-story masonry shear walls, which then transfer the combined lateral forces to the foundations.

Photo 7 – High roof with steel cantilevered columns

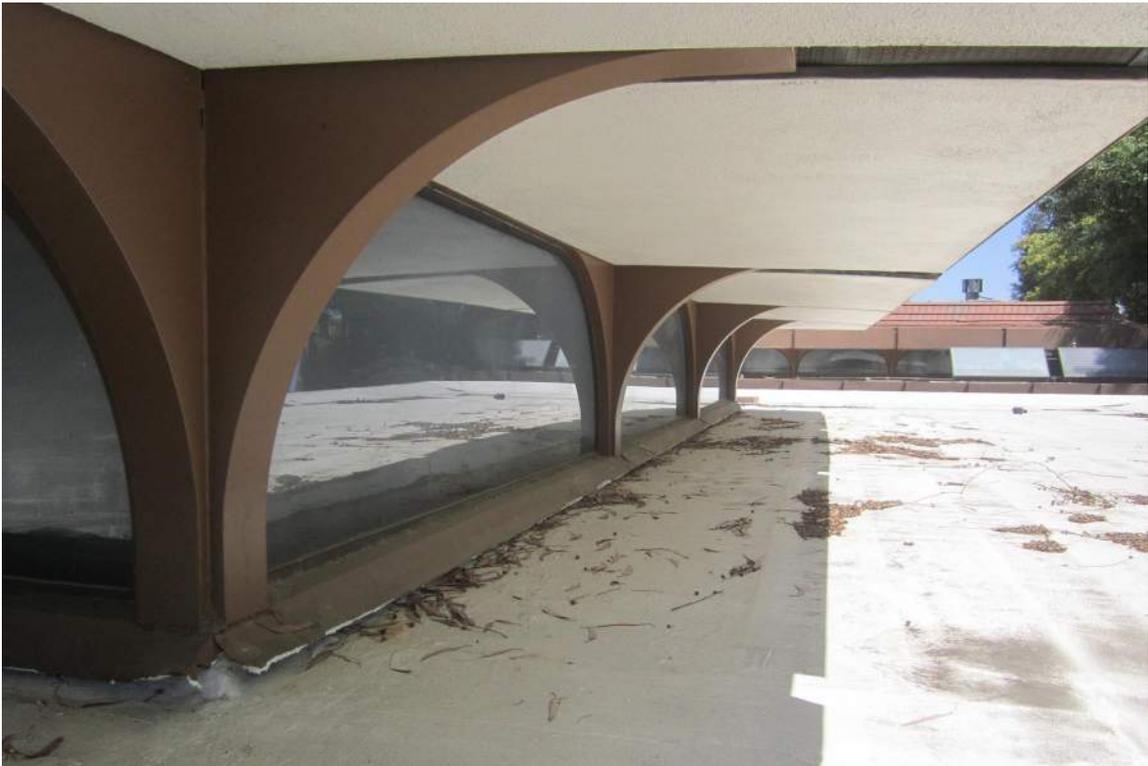
3. At the second floor level, the wood shear walls are inadequate to transfer in-plane seismic loads. Addition of new plywood at the existing shear walls along with steel straps, and steel rods with holdowns is required.
4. At the second floor level, the masonry wall-to-floor connections appear to be inadequate for both in-plane and out-of-plane wall loads. The addition of new anchor bolts will be required.
5. At the high roof level the steel cantilever columns are inadequate for transferring seismic loads into the main roof diaphragm. New infill stud walls with plywood sheathing are required.

Photo 8 – Clearstory at High roof

1. At low roof level, provide new collectors along shear wall lines by adding new steel straps over plywood sheathing, with new blocking between the joists. [See Deficiency 1 above].
2. At second floor level, provide building cross-ties by adding new horizontal steel straps or steel rods with holdowns at beam splice locations (typically at columns). [See Deficiency 2 above].
3. At second floor level, provide new plywood at several existing shear walls along with new steel straps and steel rods with holdowns. [See Deficiency 3 above].
4. At the second floor level, provide new anchors bolts drilled through the existing wood sill plate and epoxied into the top of the existing masonry walls. [See Deficiency 4 above].
5. At the high roof level, provide several new infill wood stud walls with new plywood sheathing at the clearstory between the low roof diaphragm and high roof diaphragm.

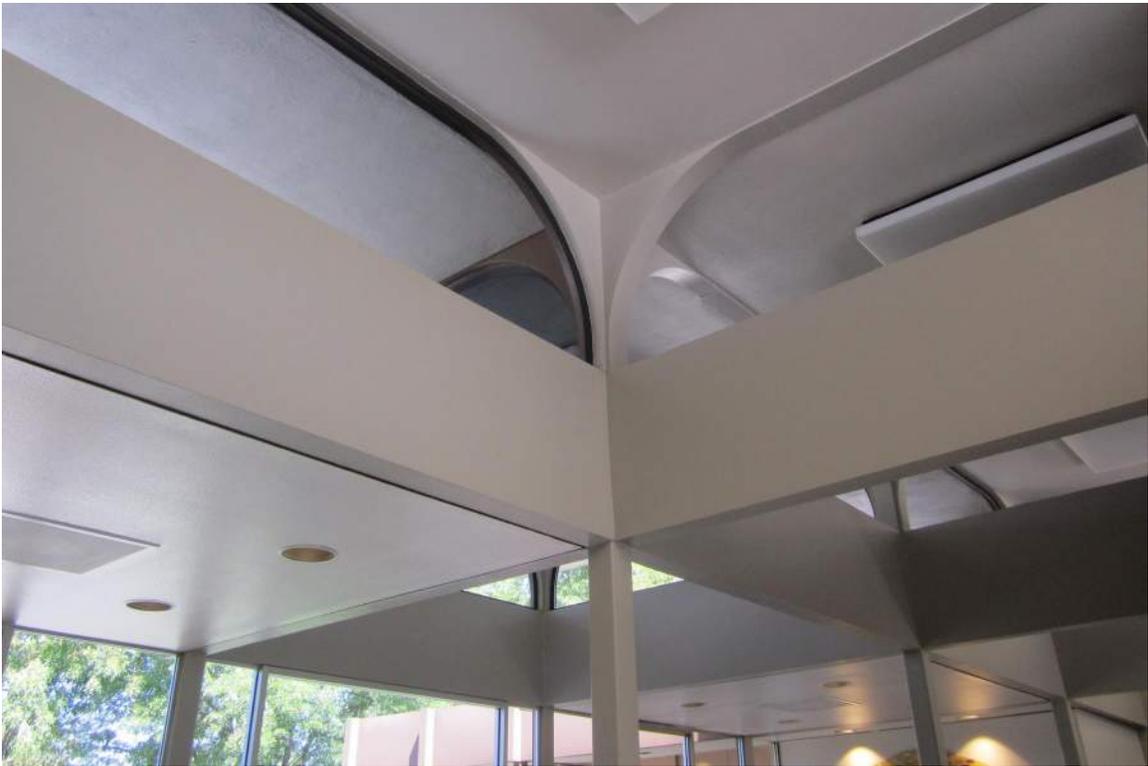
Photo 10 – Interior steel columns at second floor

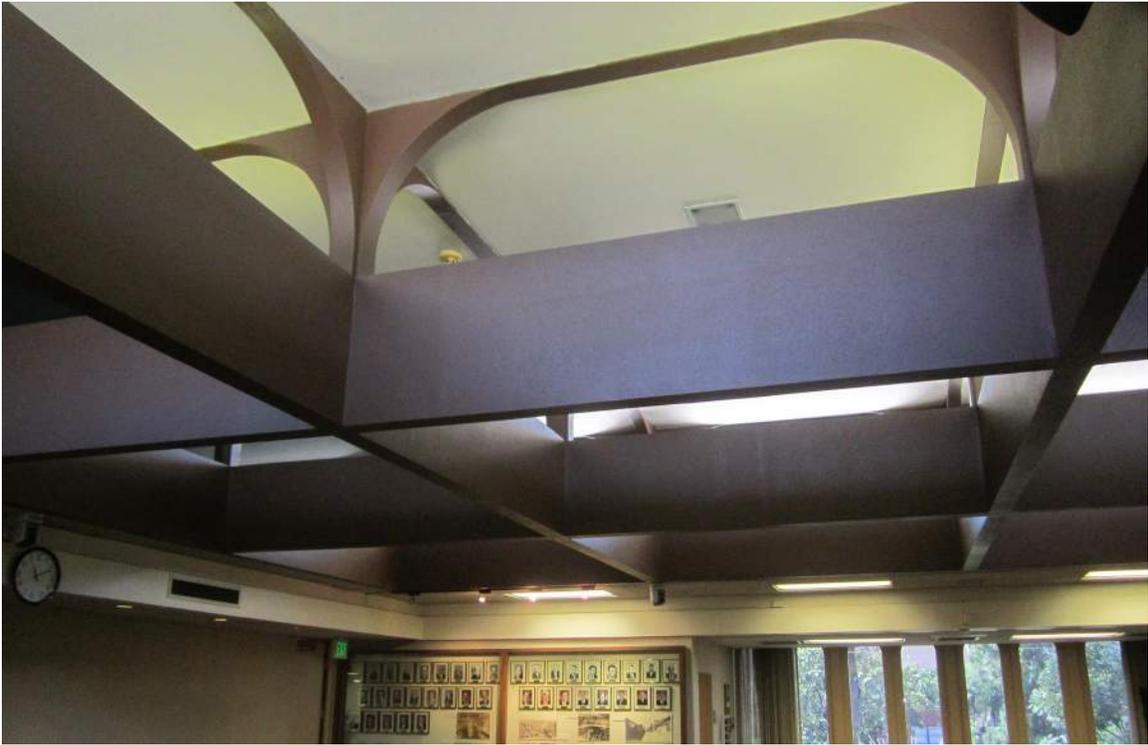
Photo 11 – Interior open roof framing below upper roof

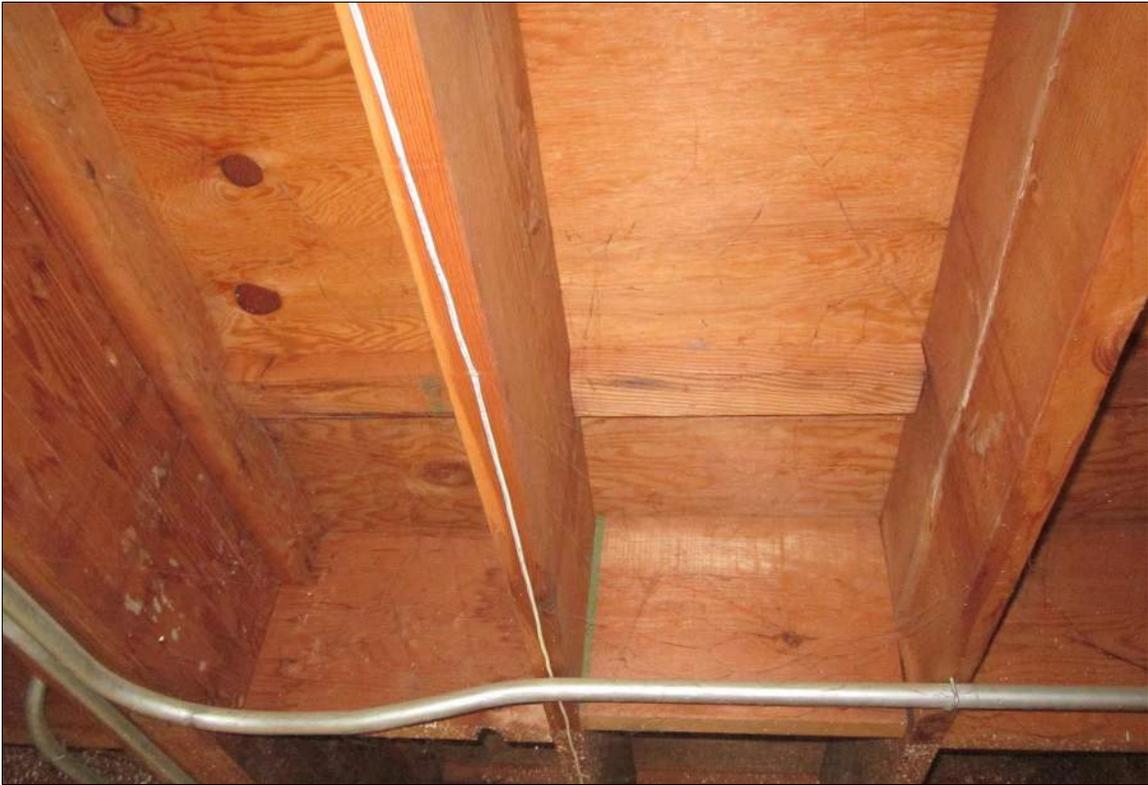
Photo 13 – Wood floor joists

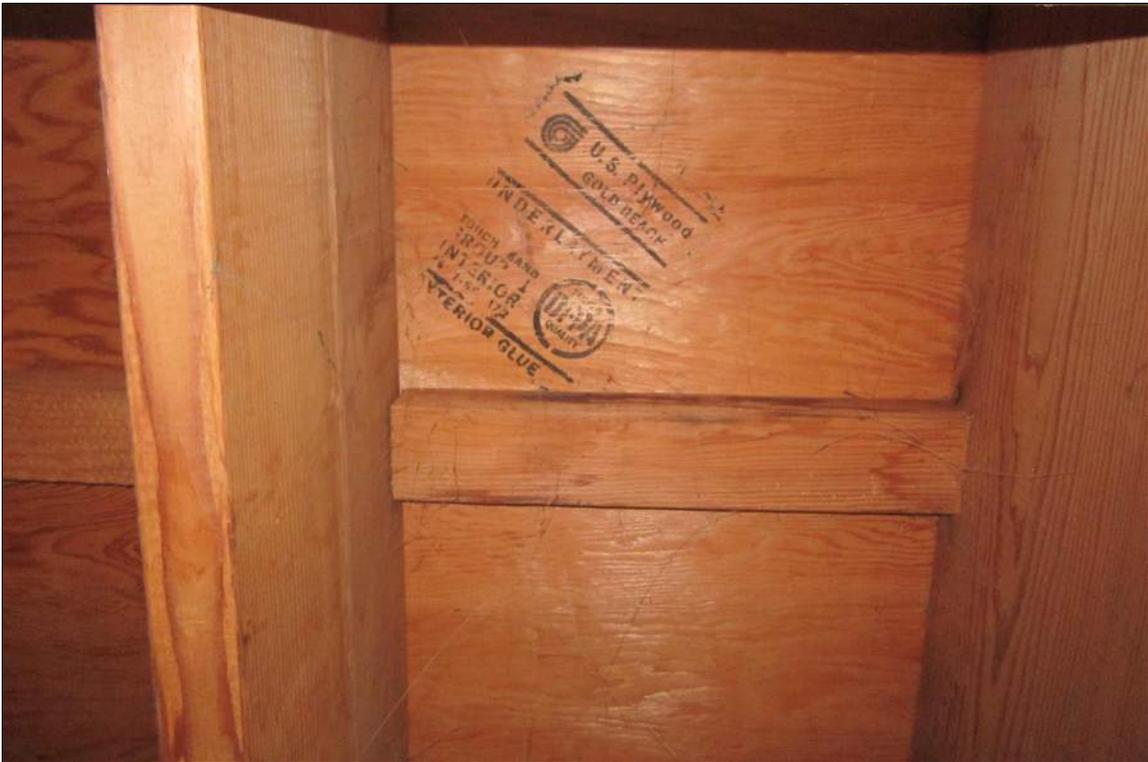
Photo 14 – Wood blocking at plywood diaphragm

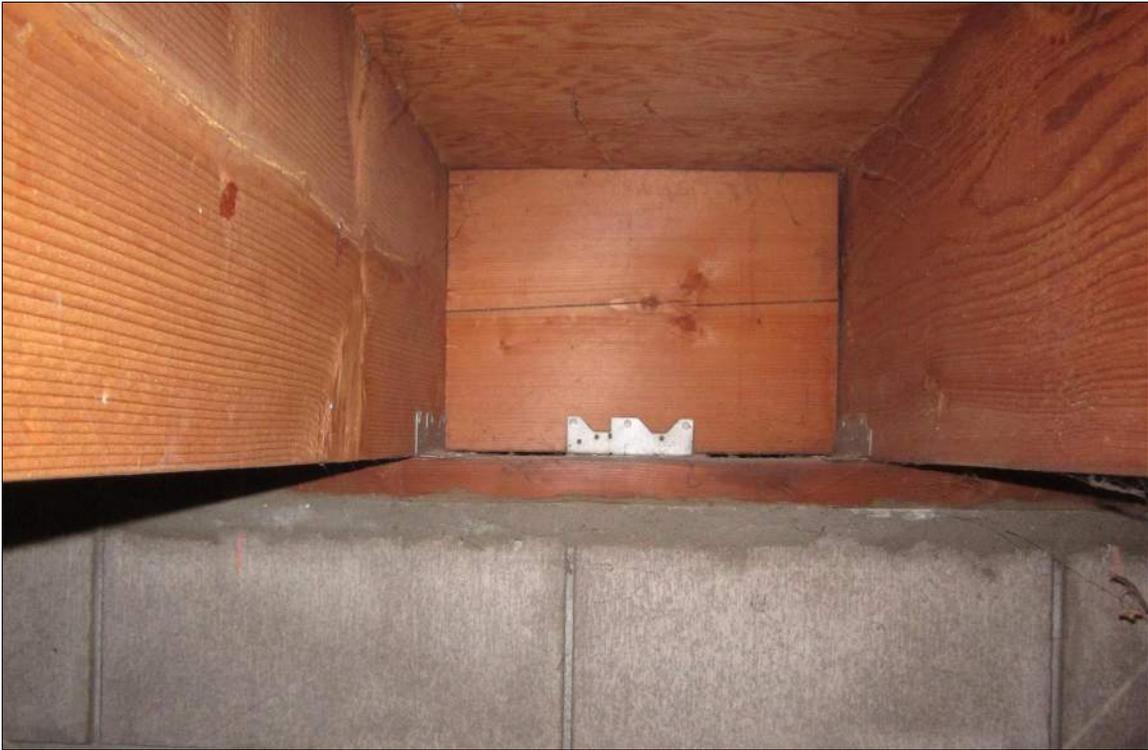
Photo 15 – Simpson steel clips at floor framing

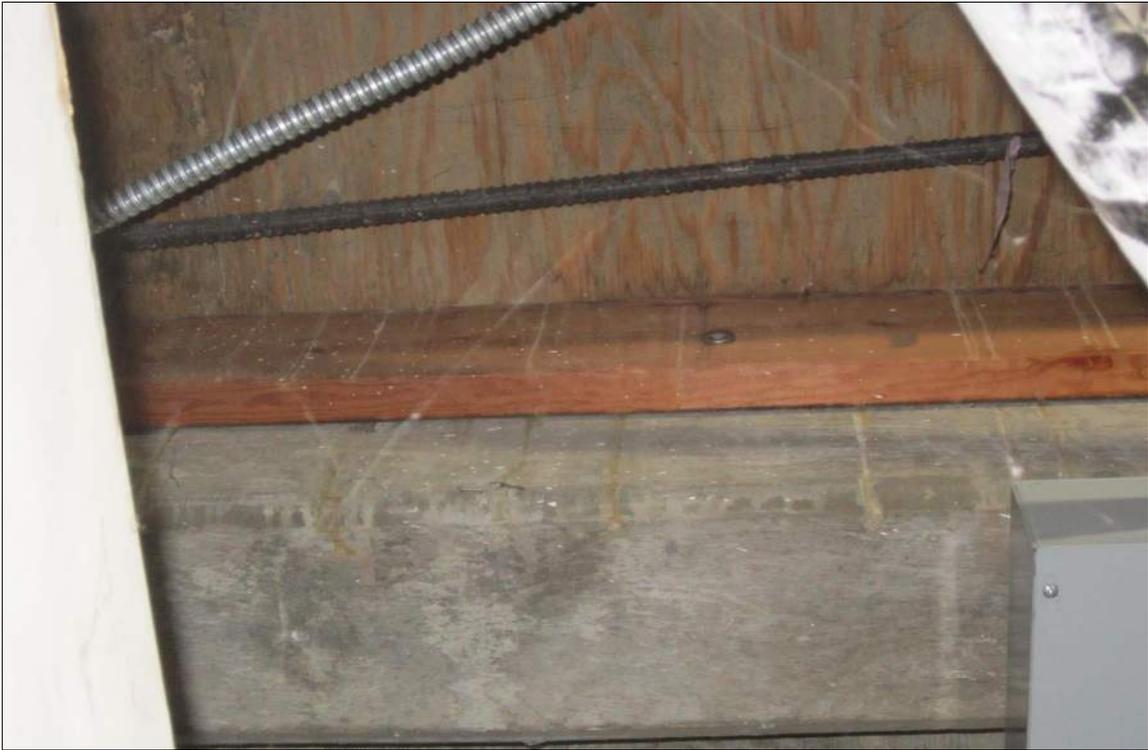
Photo 17 – Wood ledger at concrete vault
