TIER 1 SEISMIC EVALUATION
Campbell City Hall
Campbell, California

Draft Report

Prepared For:
City of Campbell
70 North First Street
Campbell, California

November 12, 2015

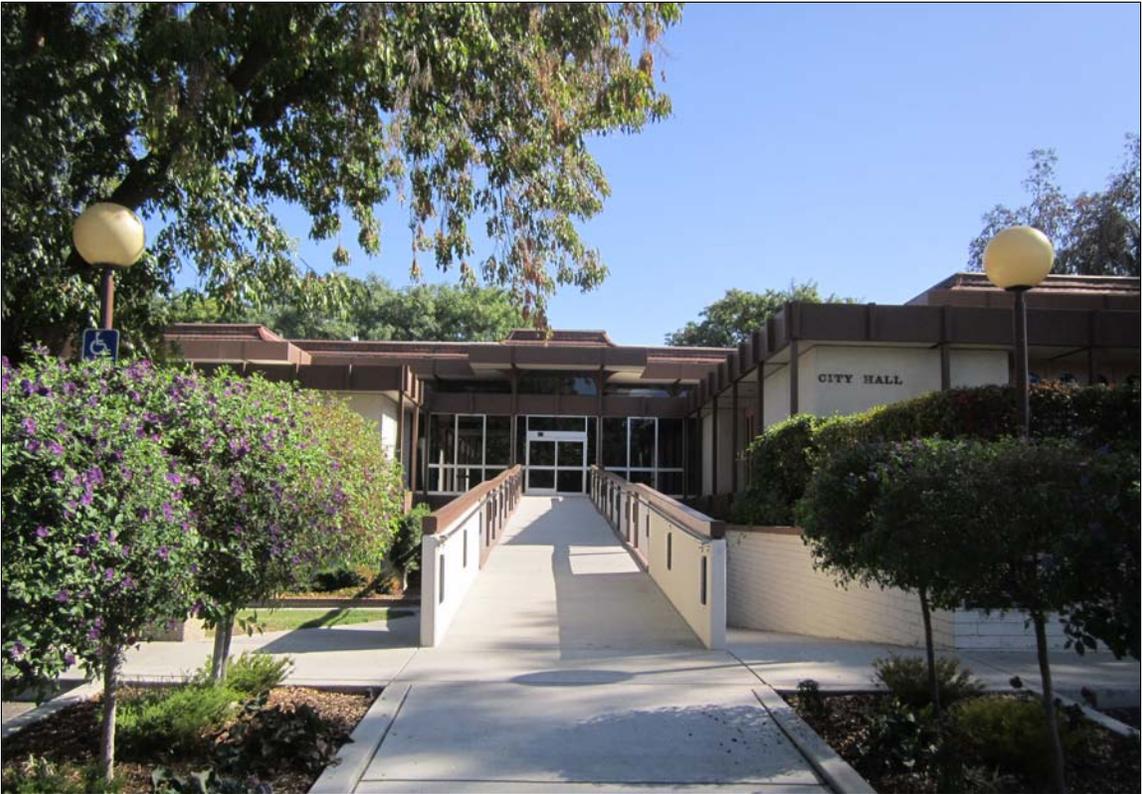
Photo 1 – West elevation view

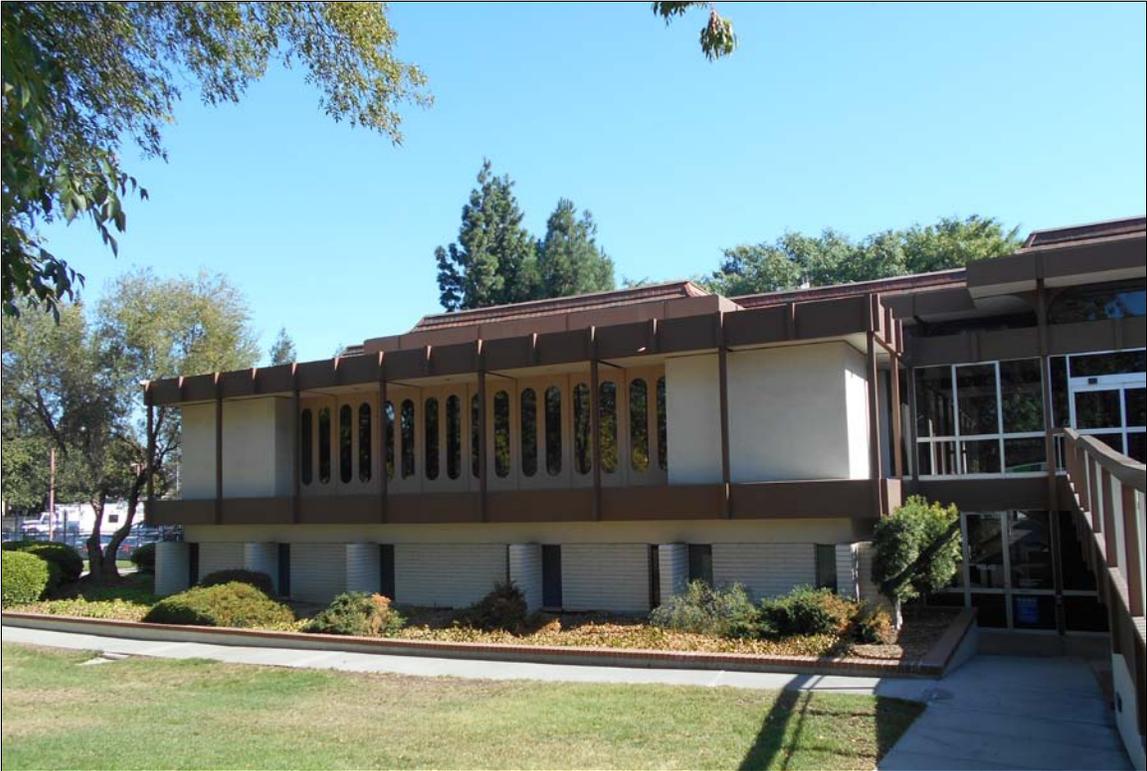
Photo 2 – West elevation view (north end)

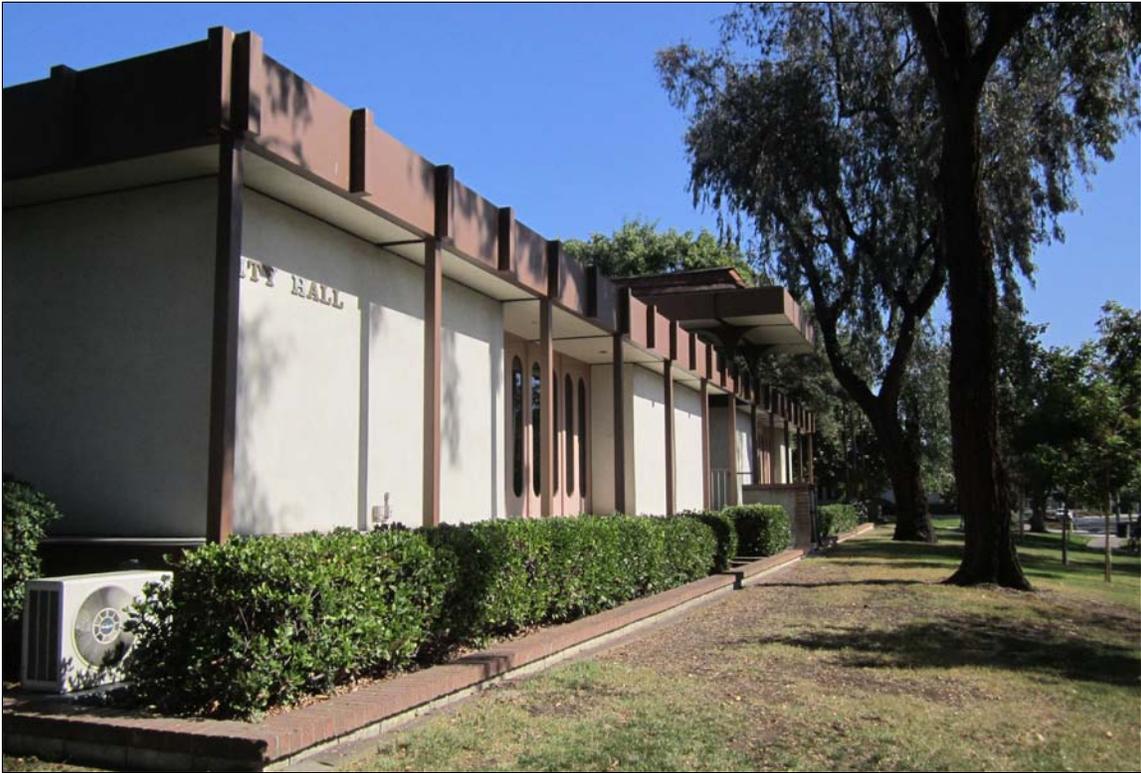
Photo 3 – South elevation view

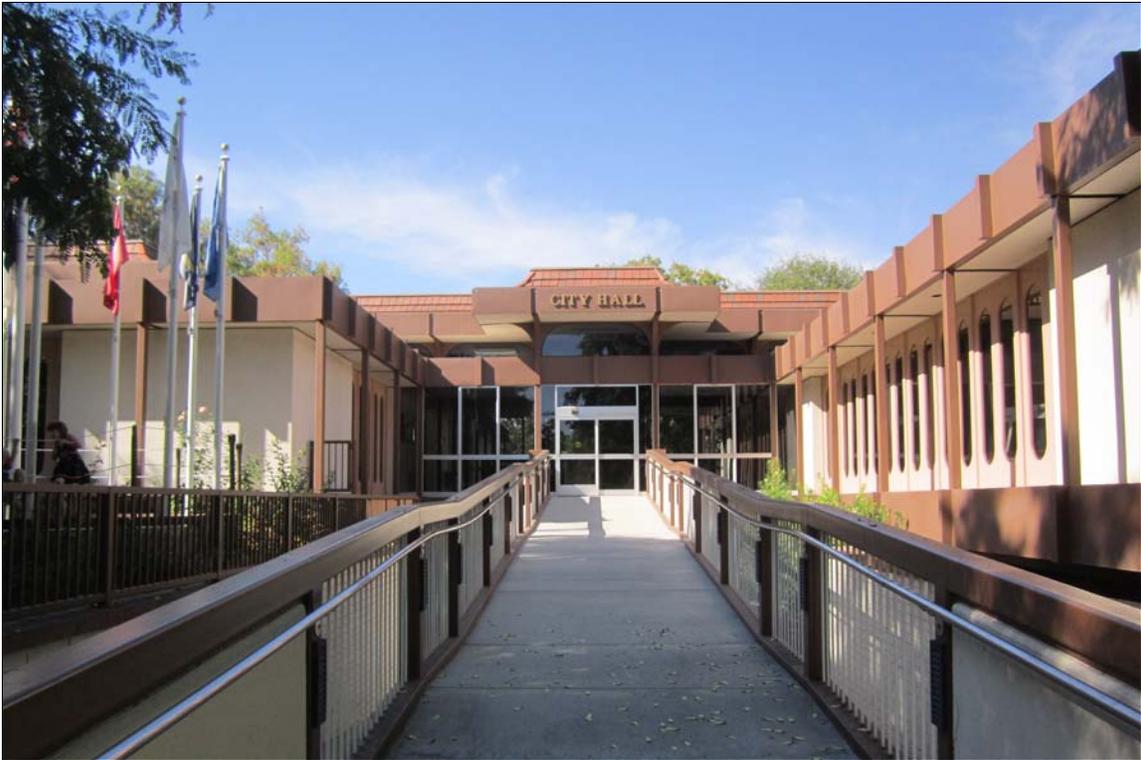
Photo 4 – East entrance view

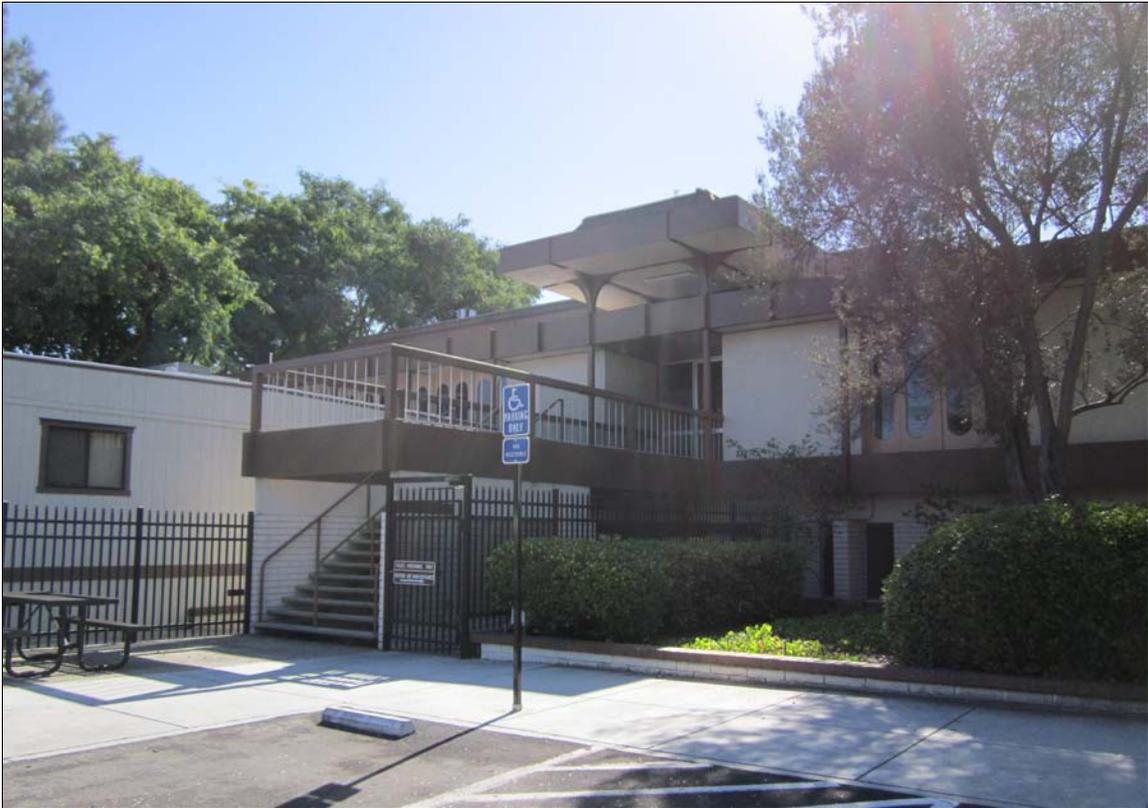
Photo 5 – North elevation view

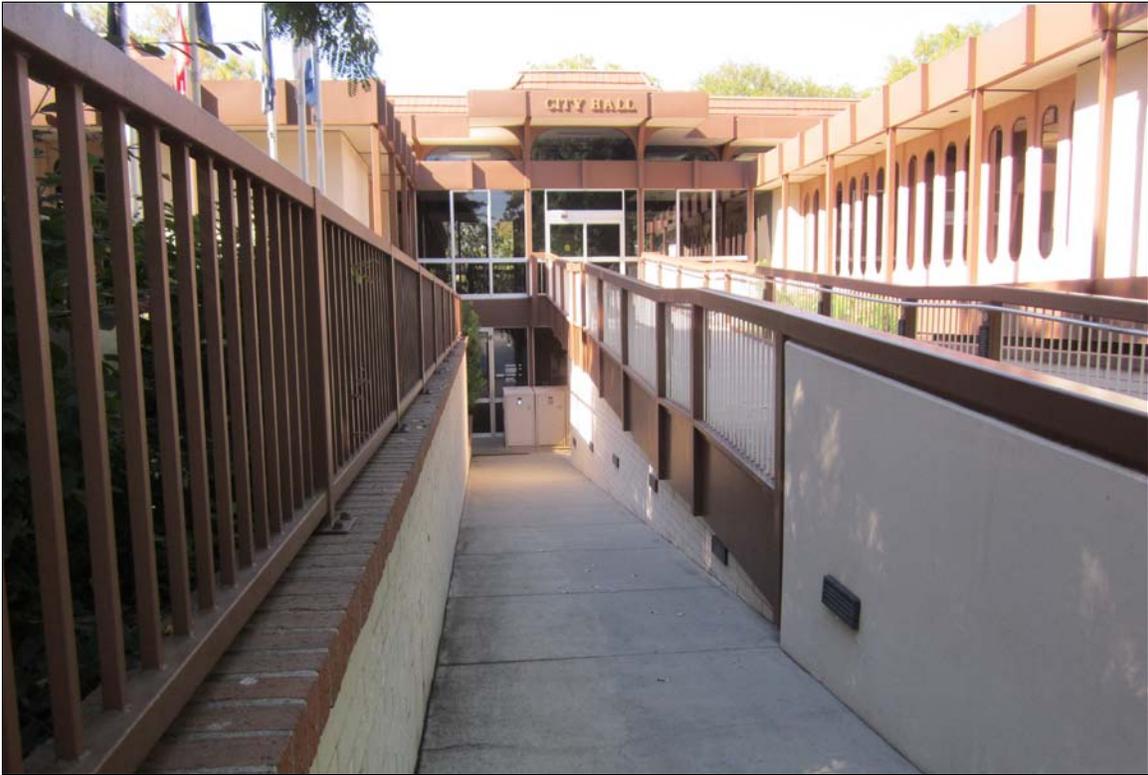
Photo 6 – Ramp at East entrance

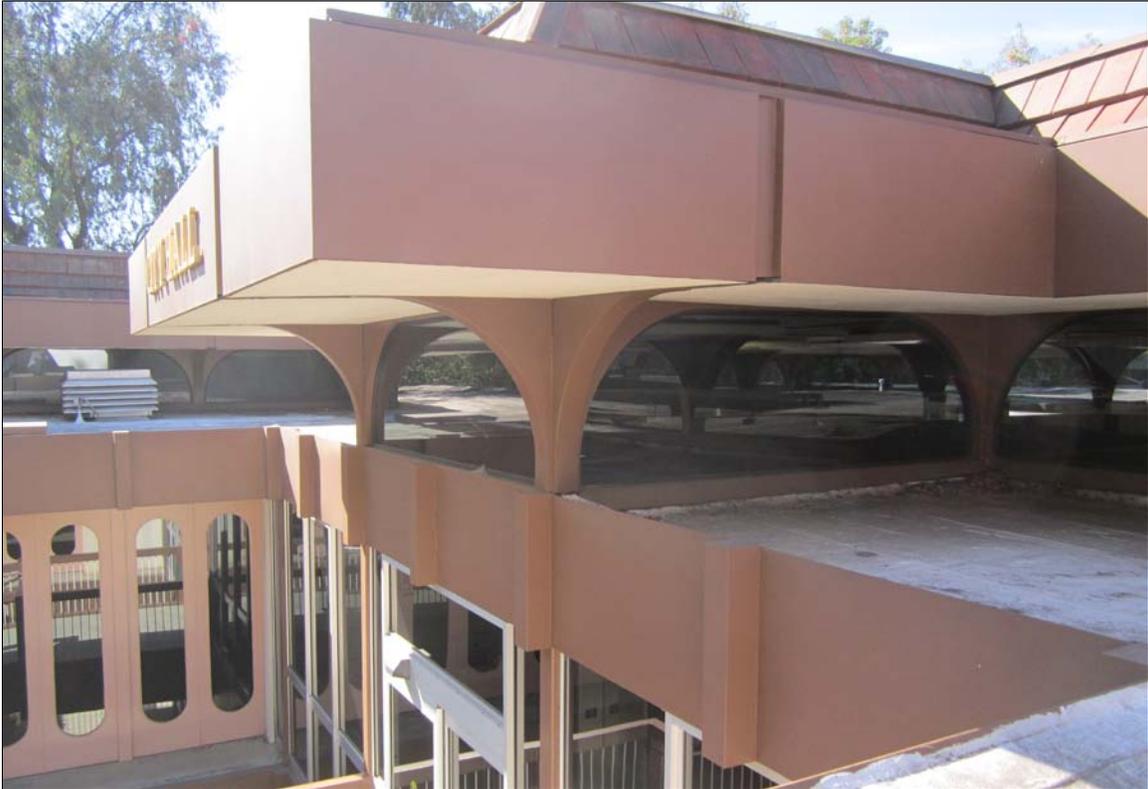
Photo 7 – High roof with steel cantilevered columns

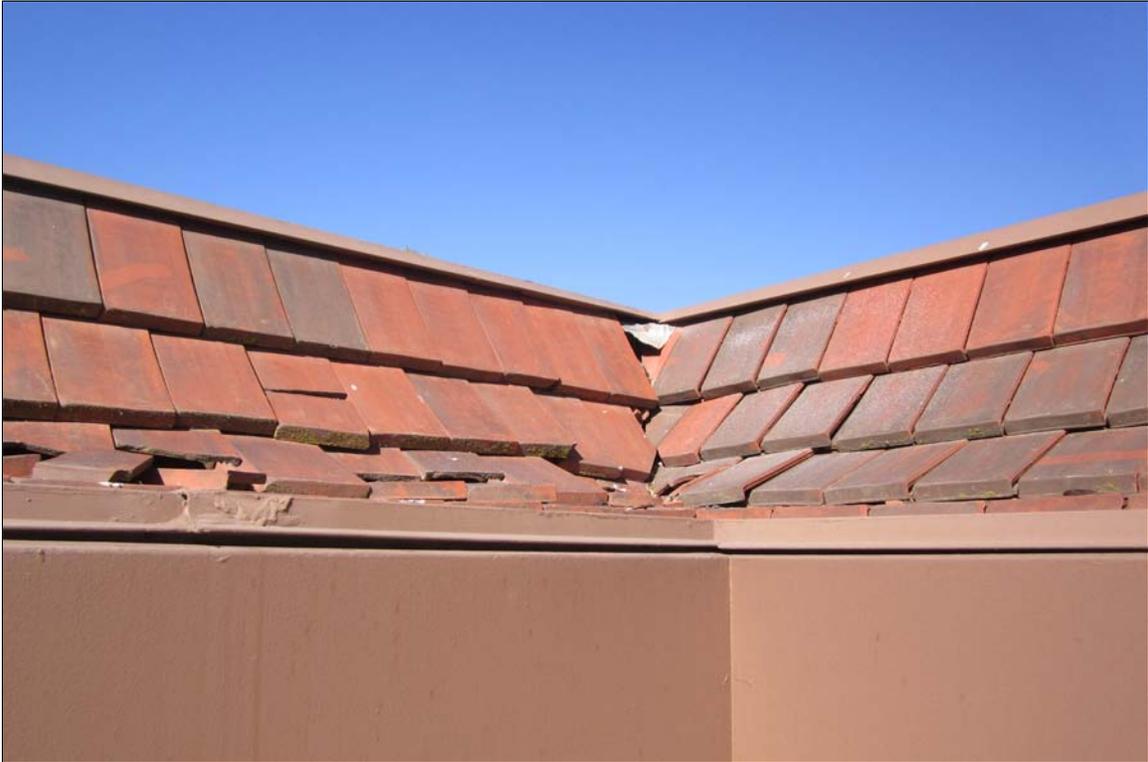
Photo 8 – Broken tiles at upper roof

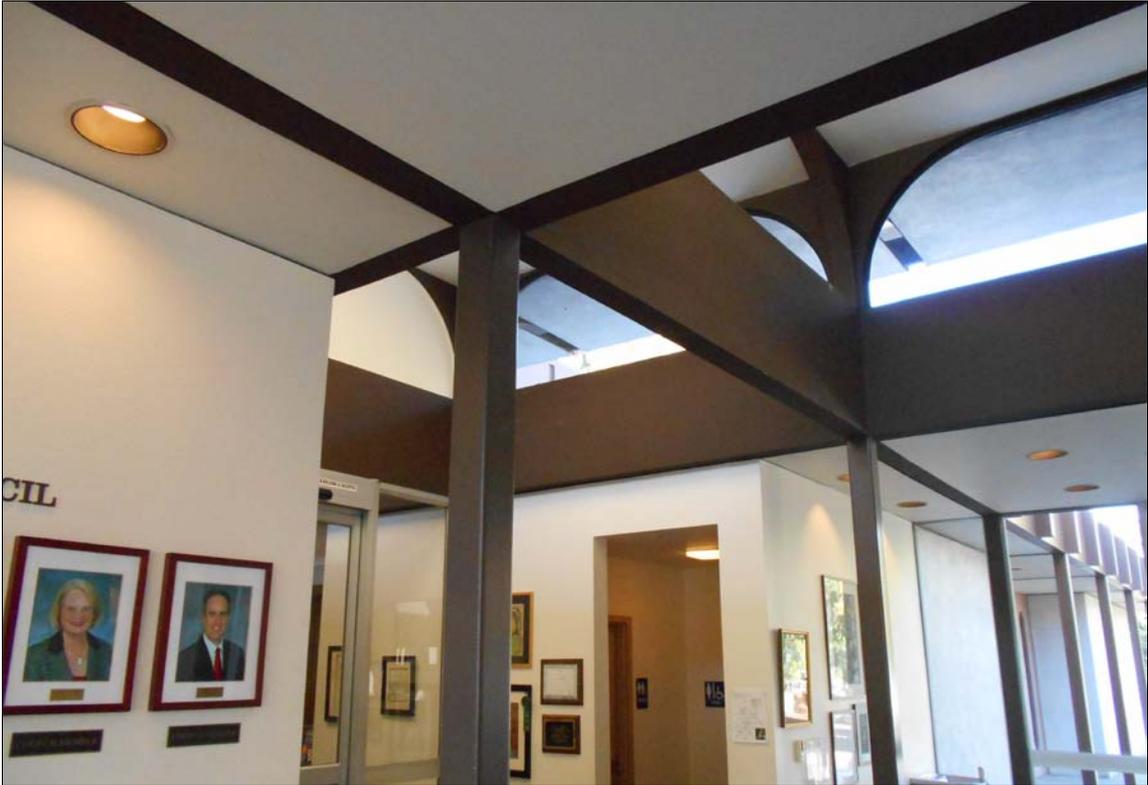
Photo 9 – Interior steel columns at second floor

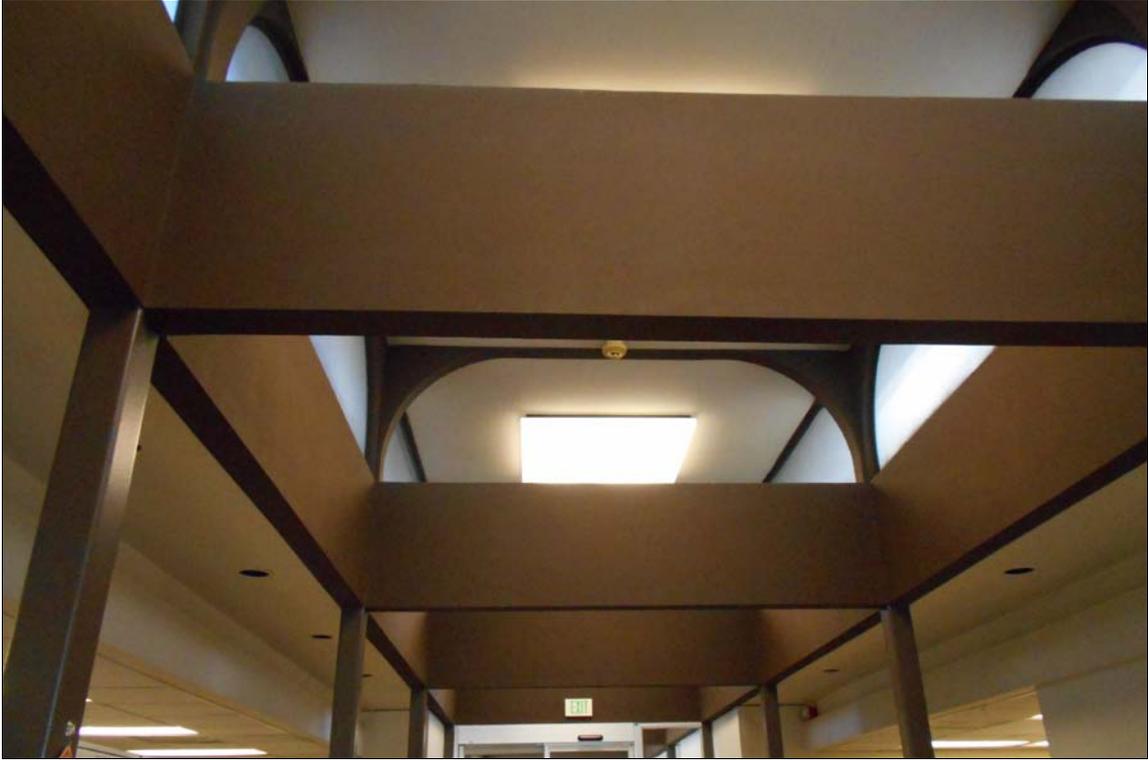
Photo 10 – Interior open roof framing below upper roof

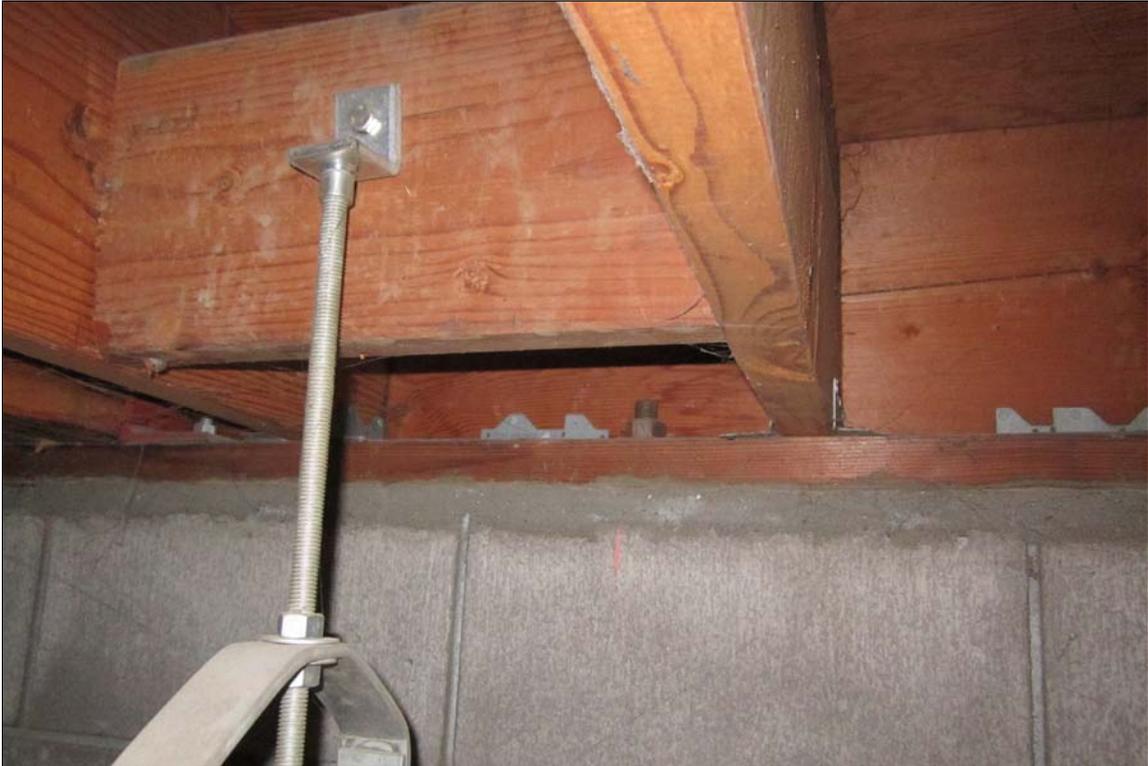
Photo 11 – Bolted wood sill plate at masonry wall

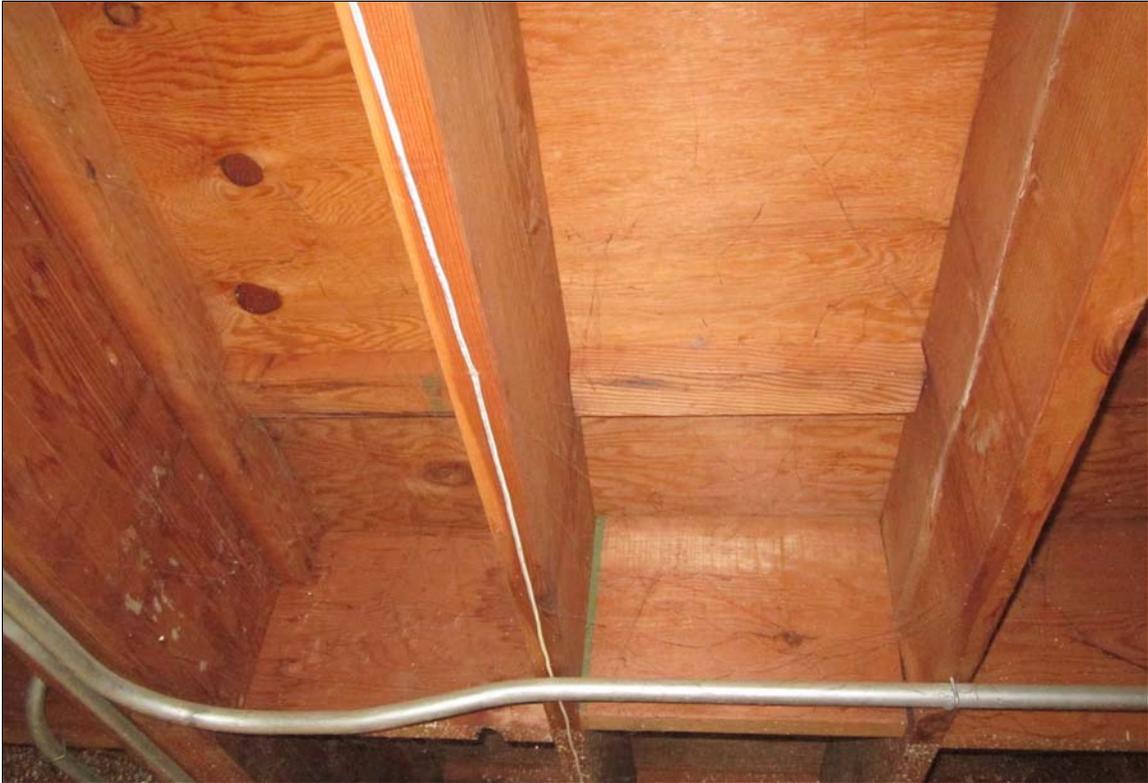
Photo 12 – Wood floor joists

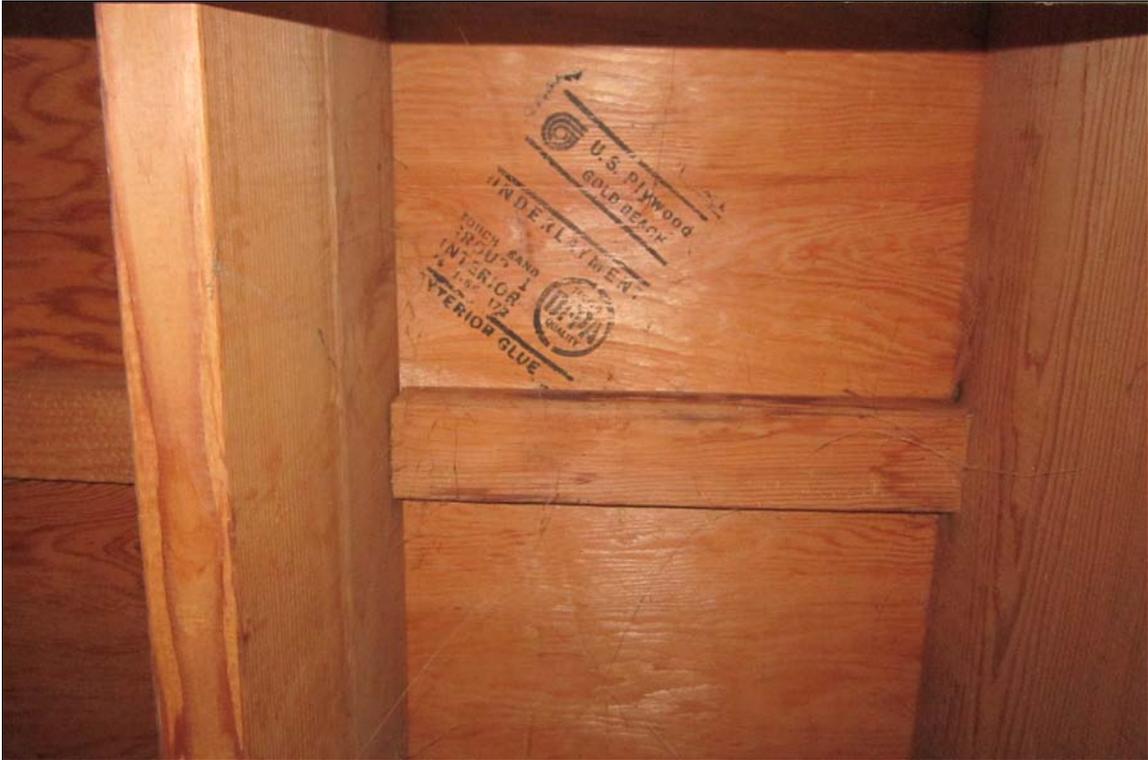
Photo 13 – Wood blocking at plywood diaphragm

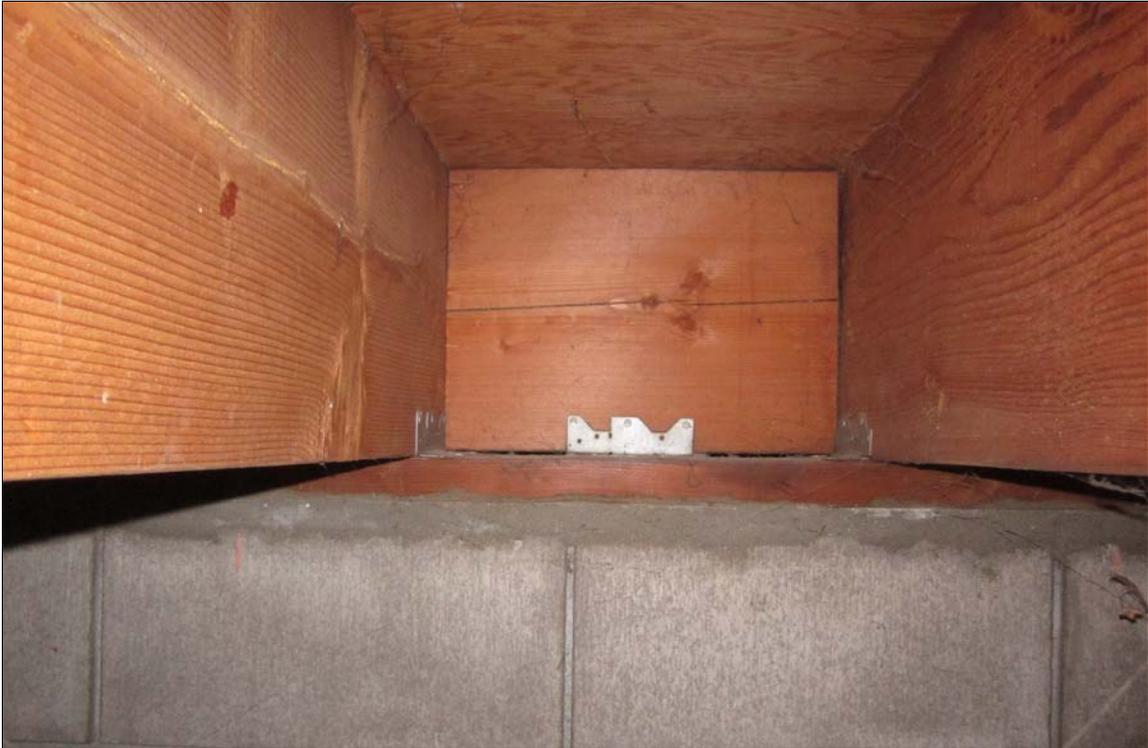
Photo 14 – Simpson steel clips at floor framing

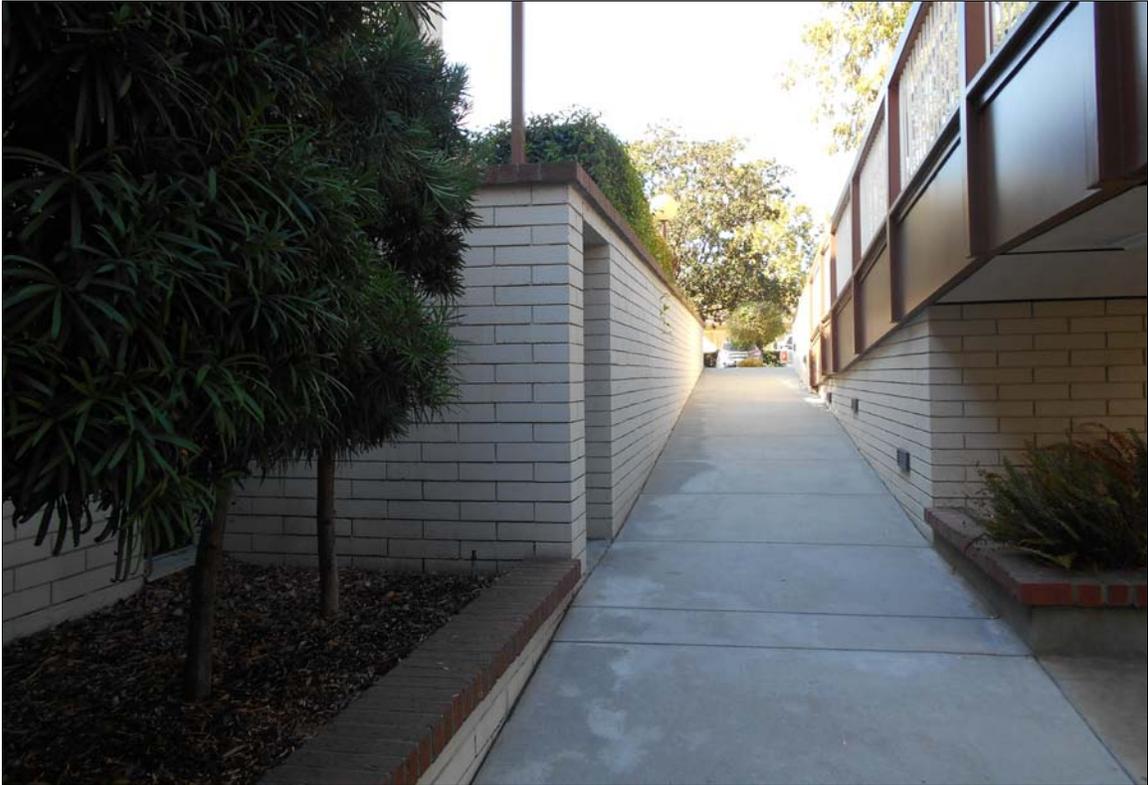
Photo 15 – Ramp at West elevation

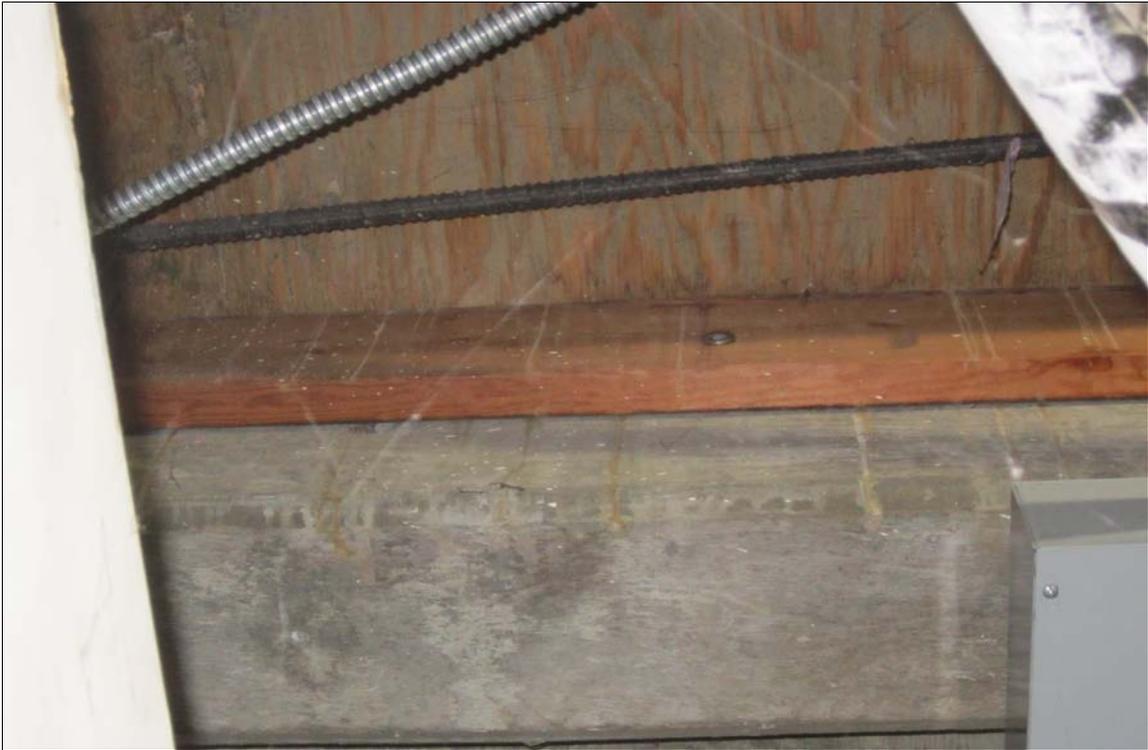
Photo 16 – Wood ledger at concrete vault
