TIER 1 SEISMIC EVALUATION

Campbell Library

Draft Report

May 13, 2015

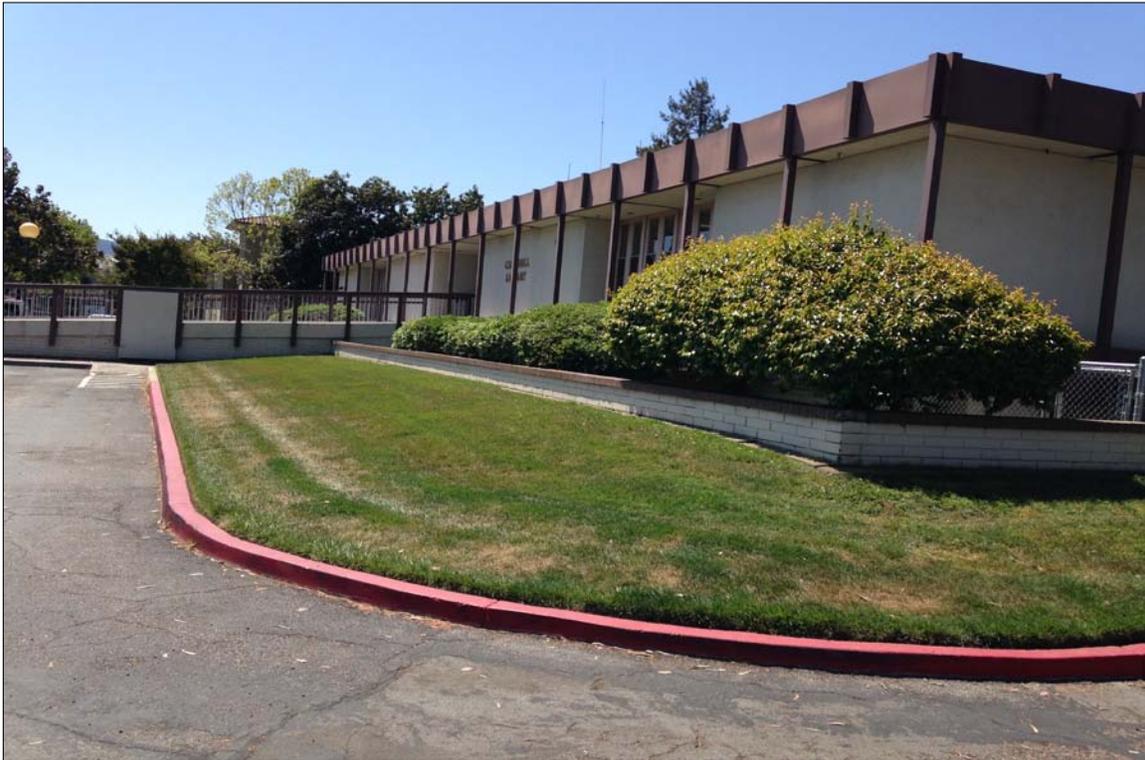
Photo 1 – East elevation view

The building is located on a flat site. The first story is partially depressed below grade with the exterior masonry walls retaining soil up to approximately their mid-height. There is a short (2 to 3-ft height) masonry retaining wall approximately 10-ft away from the building footprint enclosing the entire perimeter of the building. The finished grade slopes down several feet from this retaining wall to a level just below the windows in the masonry walls at the building perimeter, resulting in surface runoff draining toward the building. See Photos 1 through 5.

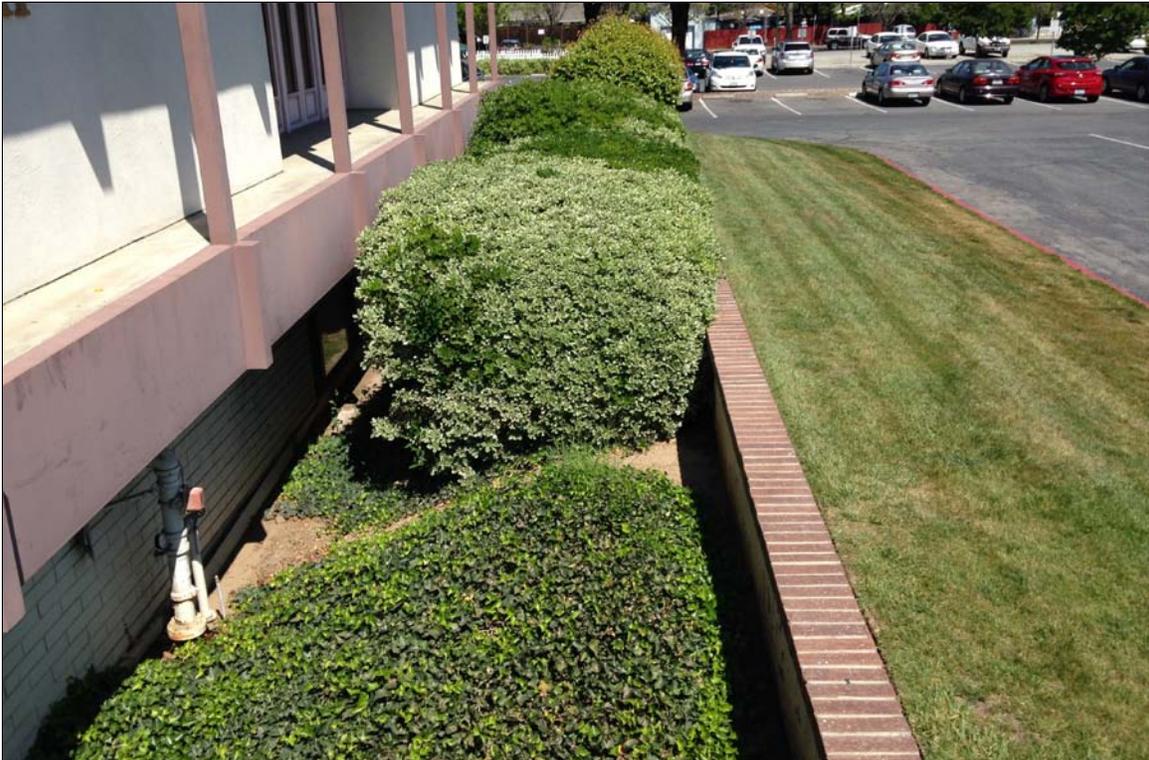
Photo 5 – Exterior perimeter retaining wall and first story masonry walls.

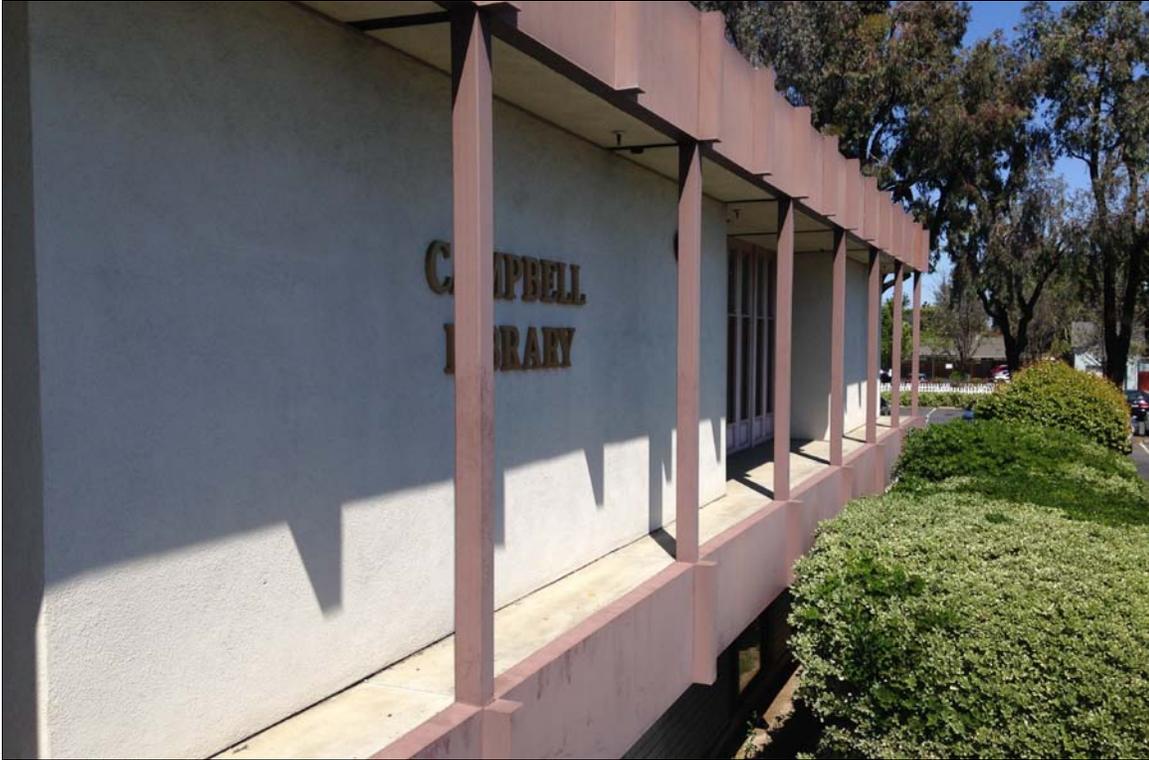
Photo 6 – Exterior overhangs and steel columns

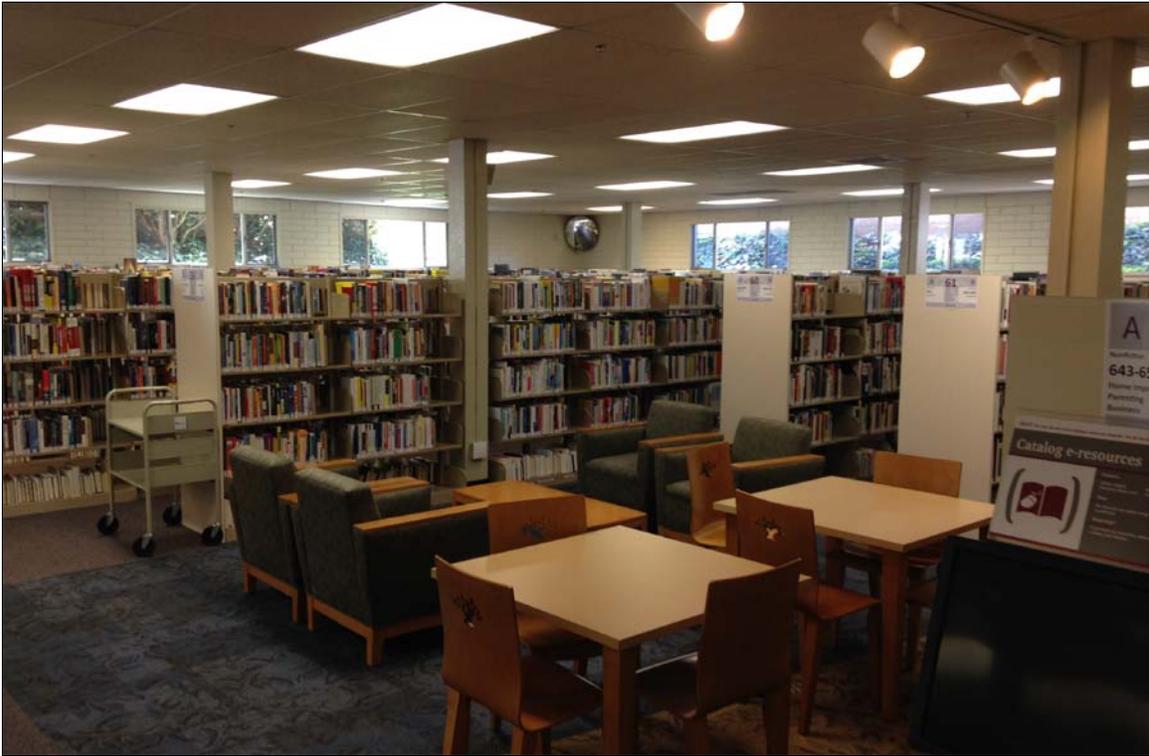
Photo 7 – Interior space at first floor with masonry shearwalls beyond

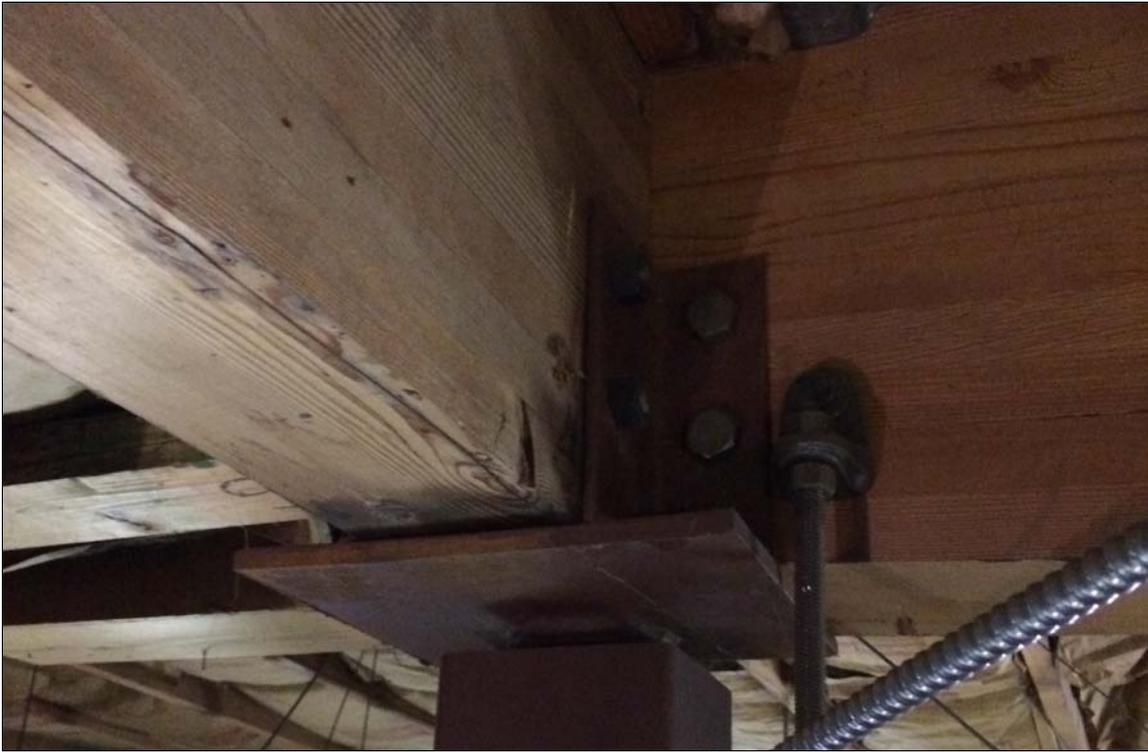
Photo 9 – Typical glulam beam to steel column connection

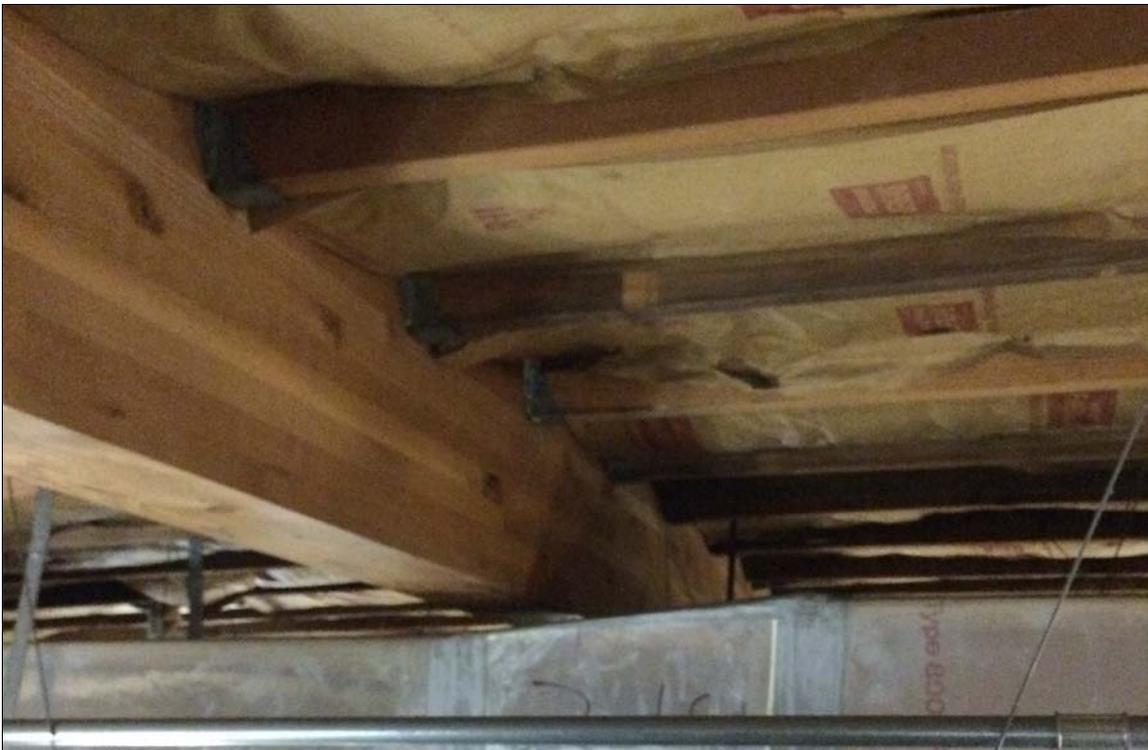
Photo 10 – Typical Joist to glulam beam connection

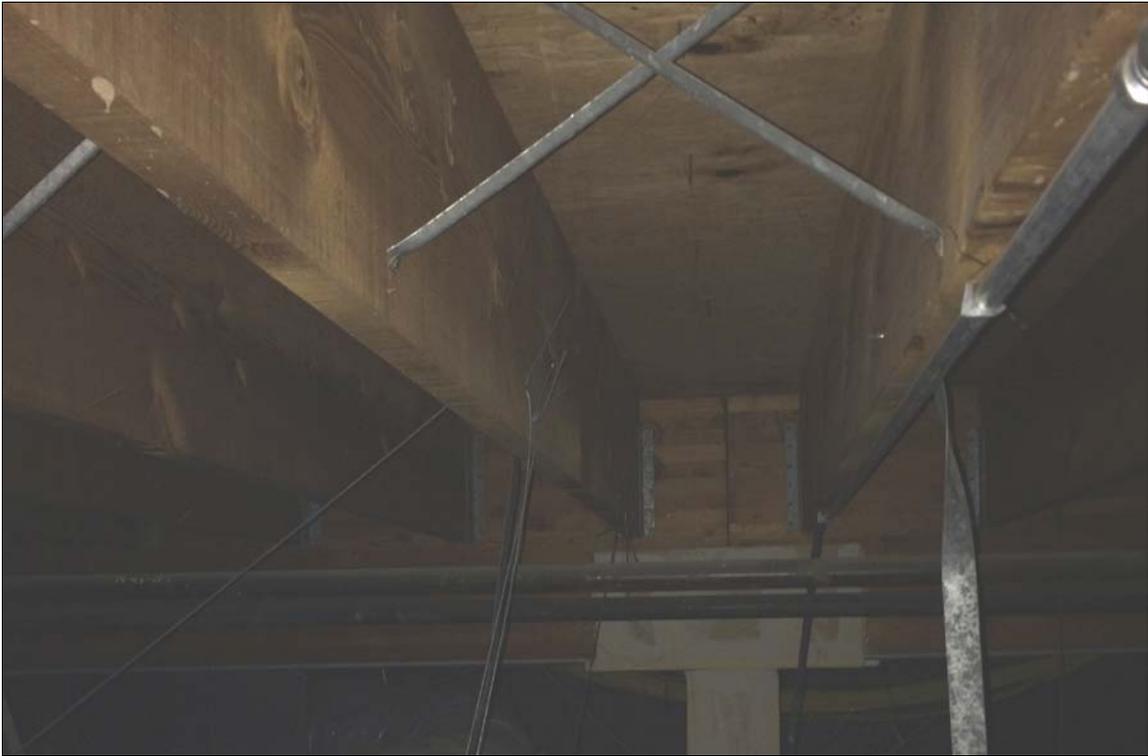
Photo 11 – Joist bridging and glulam beam to column connection beyond

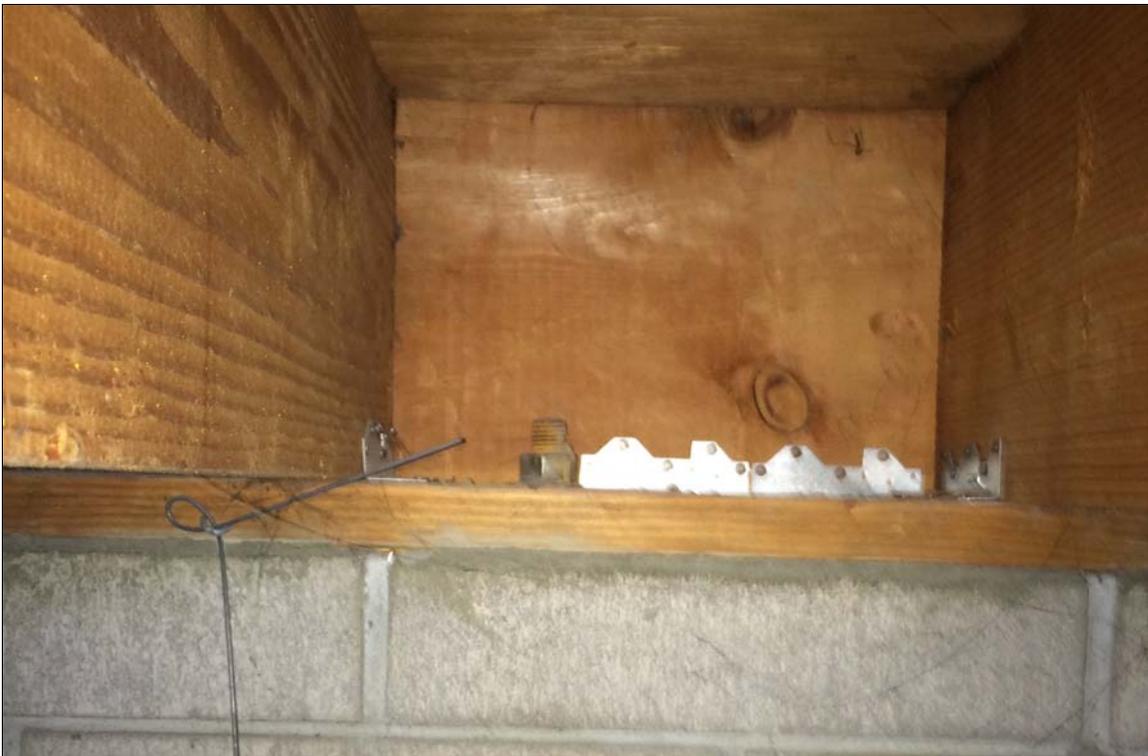
Photo 12 – Bolted wood sill plate at masonry wall

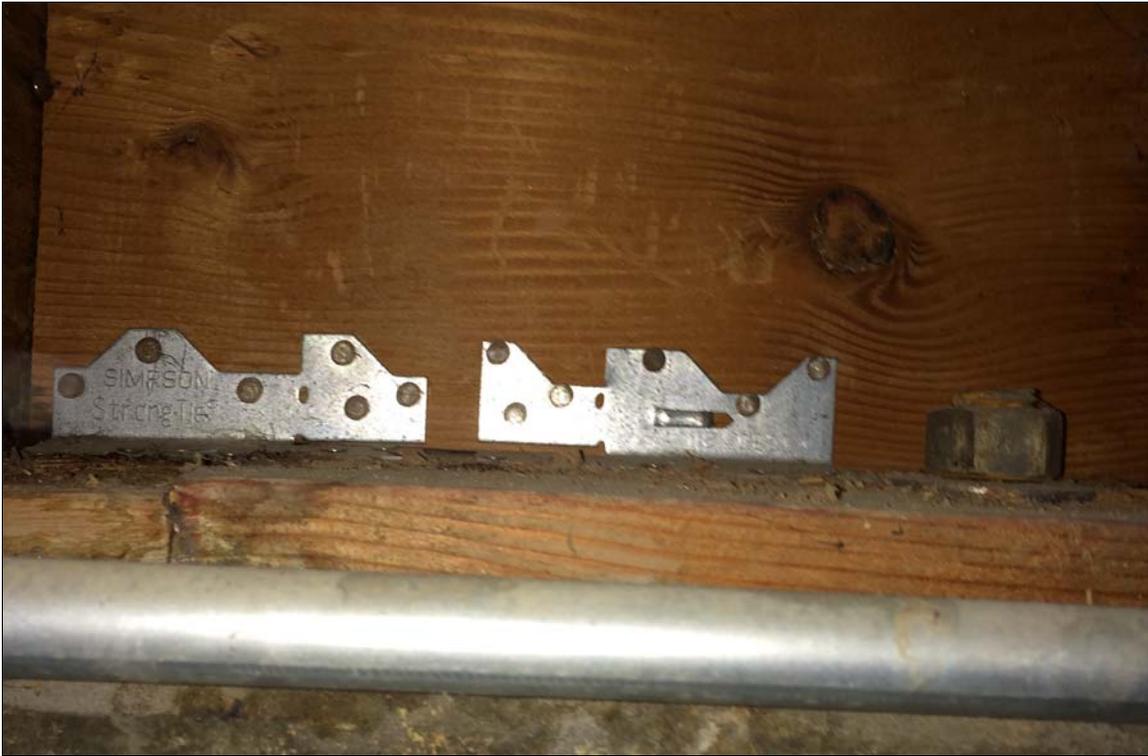
Photo 13 – Bolt and Simpson steel clips at wood sill plate

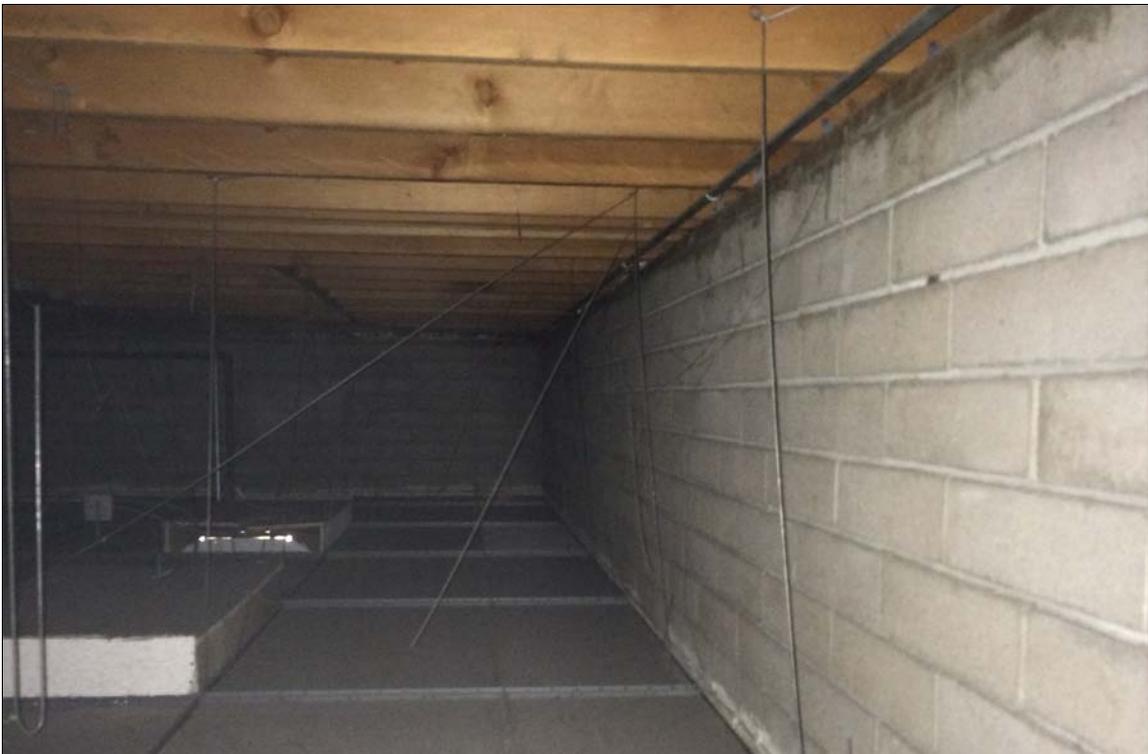
Photo 14 – Typical floor framing at masonry wall

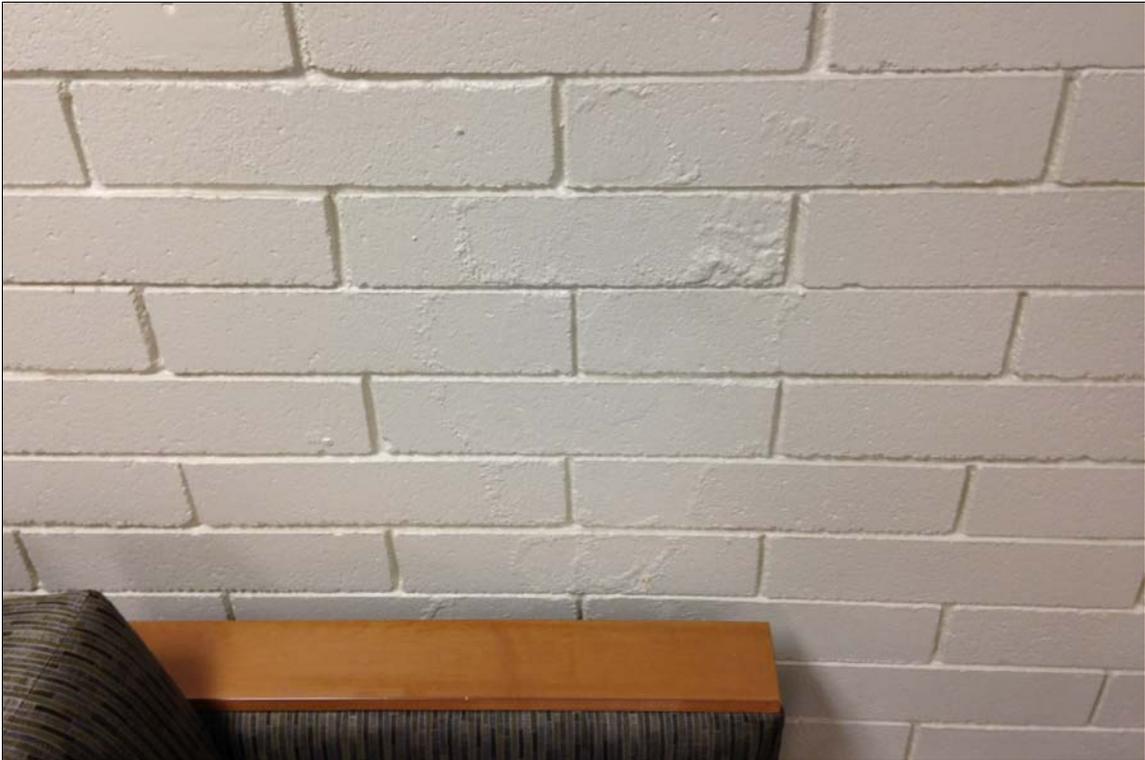
Overall the building appears to be in good physical condition. While signs of minor water intrusion were observed at several locations (see Photos 15 & 16), the wood framing observed at the second floor and roof showed no signs of moisture-related damage or any other type of deterioration. The steel columns and steel connection hardware showed no signs of corrosion. There were no visible indications (cracks in walls, slabs, sidewalks, etc.) that the building has undergone any significant settlement or differential settlement.

The masonry walls appeared to be in good structural condition. No visible cracks were present during the site visit although the masonry wall has been painted and this could obscure small cracks. Signs of previous water seepage through the masonry walls were observed at several locations, suggesting that a waterproofing/drainage system on the soil-side of masonry walls either was not originally installed or may have been compromised if

Photo 15 – Signs of water intrusion through masonry wall

We recommend that the City retain a drainage and waterproofing specialist firm to assess these issues as they pertain to the first-story masonry walls. Potential solutions to preventing water seepage through the walls may include removing all existing finish materials on interior face of wall, epoxy injection of cracks, and applying a coating/membrane to interior face of the wall, or alternatively repairing/installing the drainage and waterproofing system behind the wall.

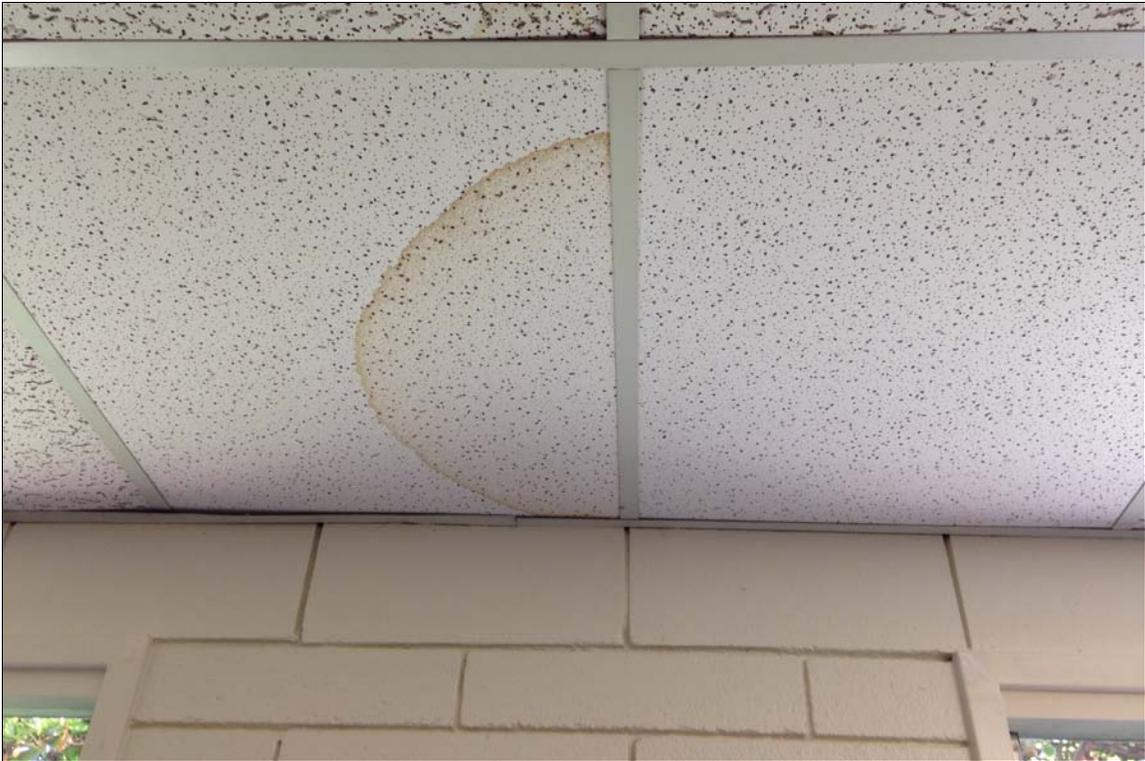
Photo 16 – Water damage at ceiling tile

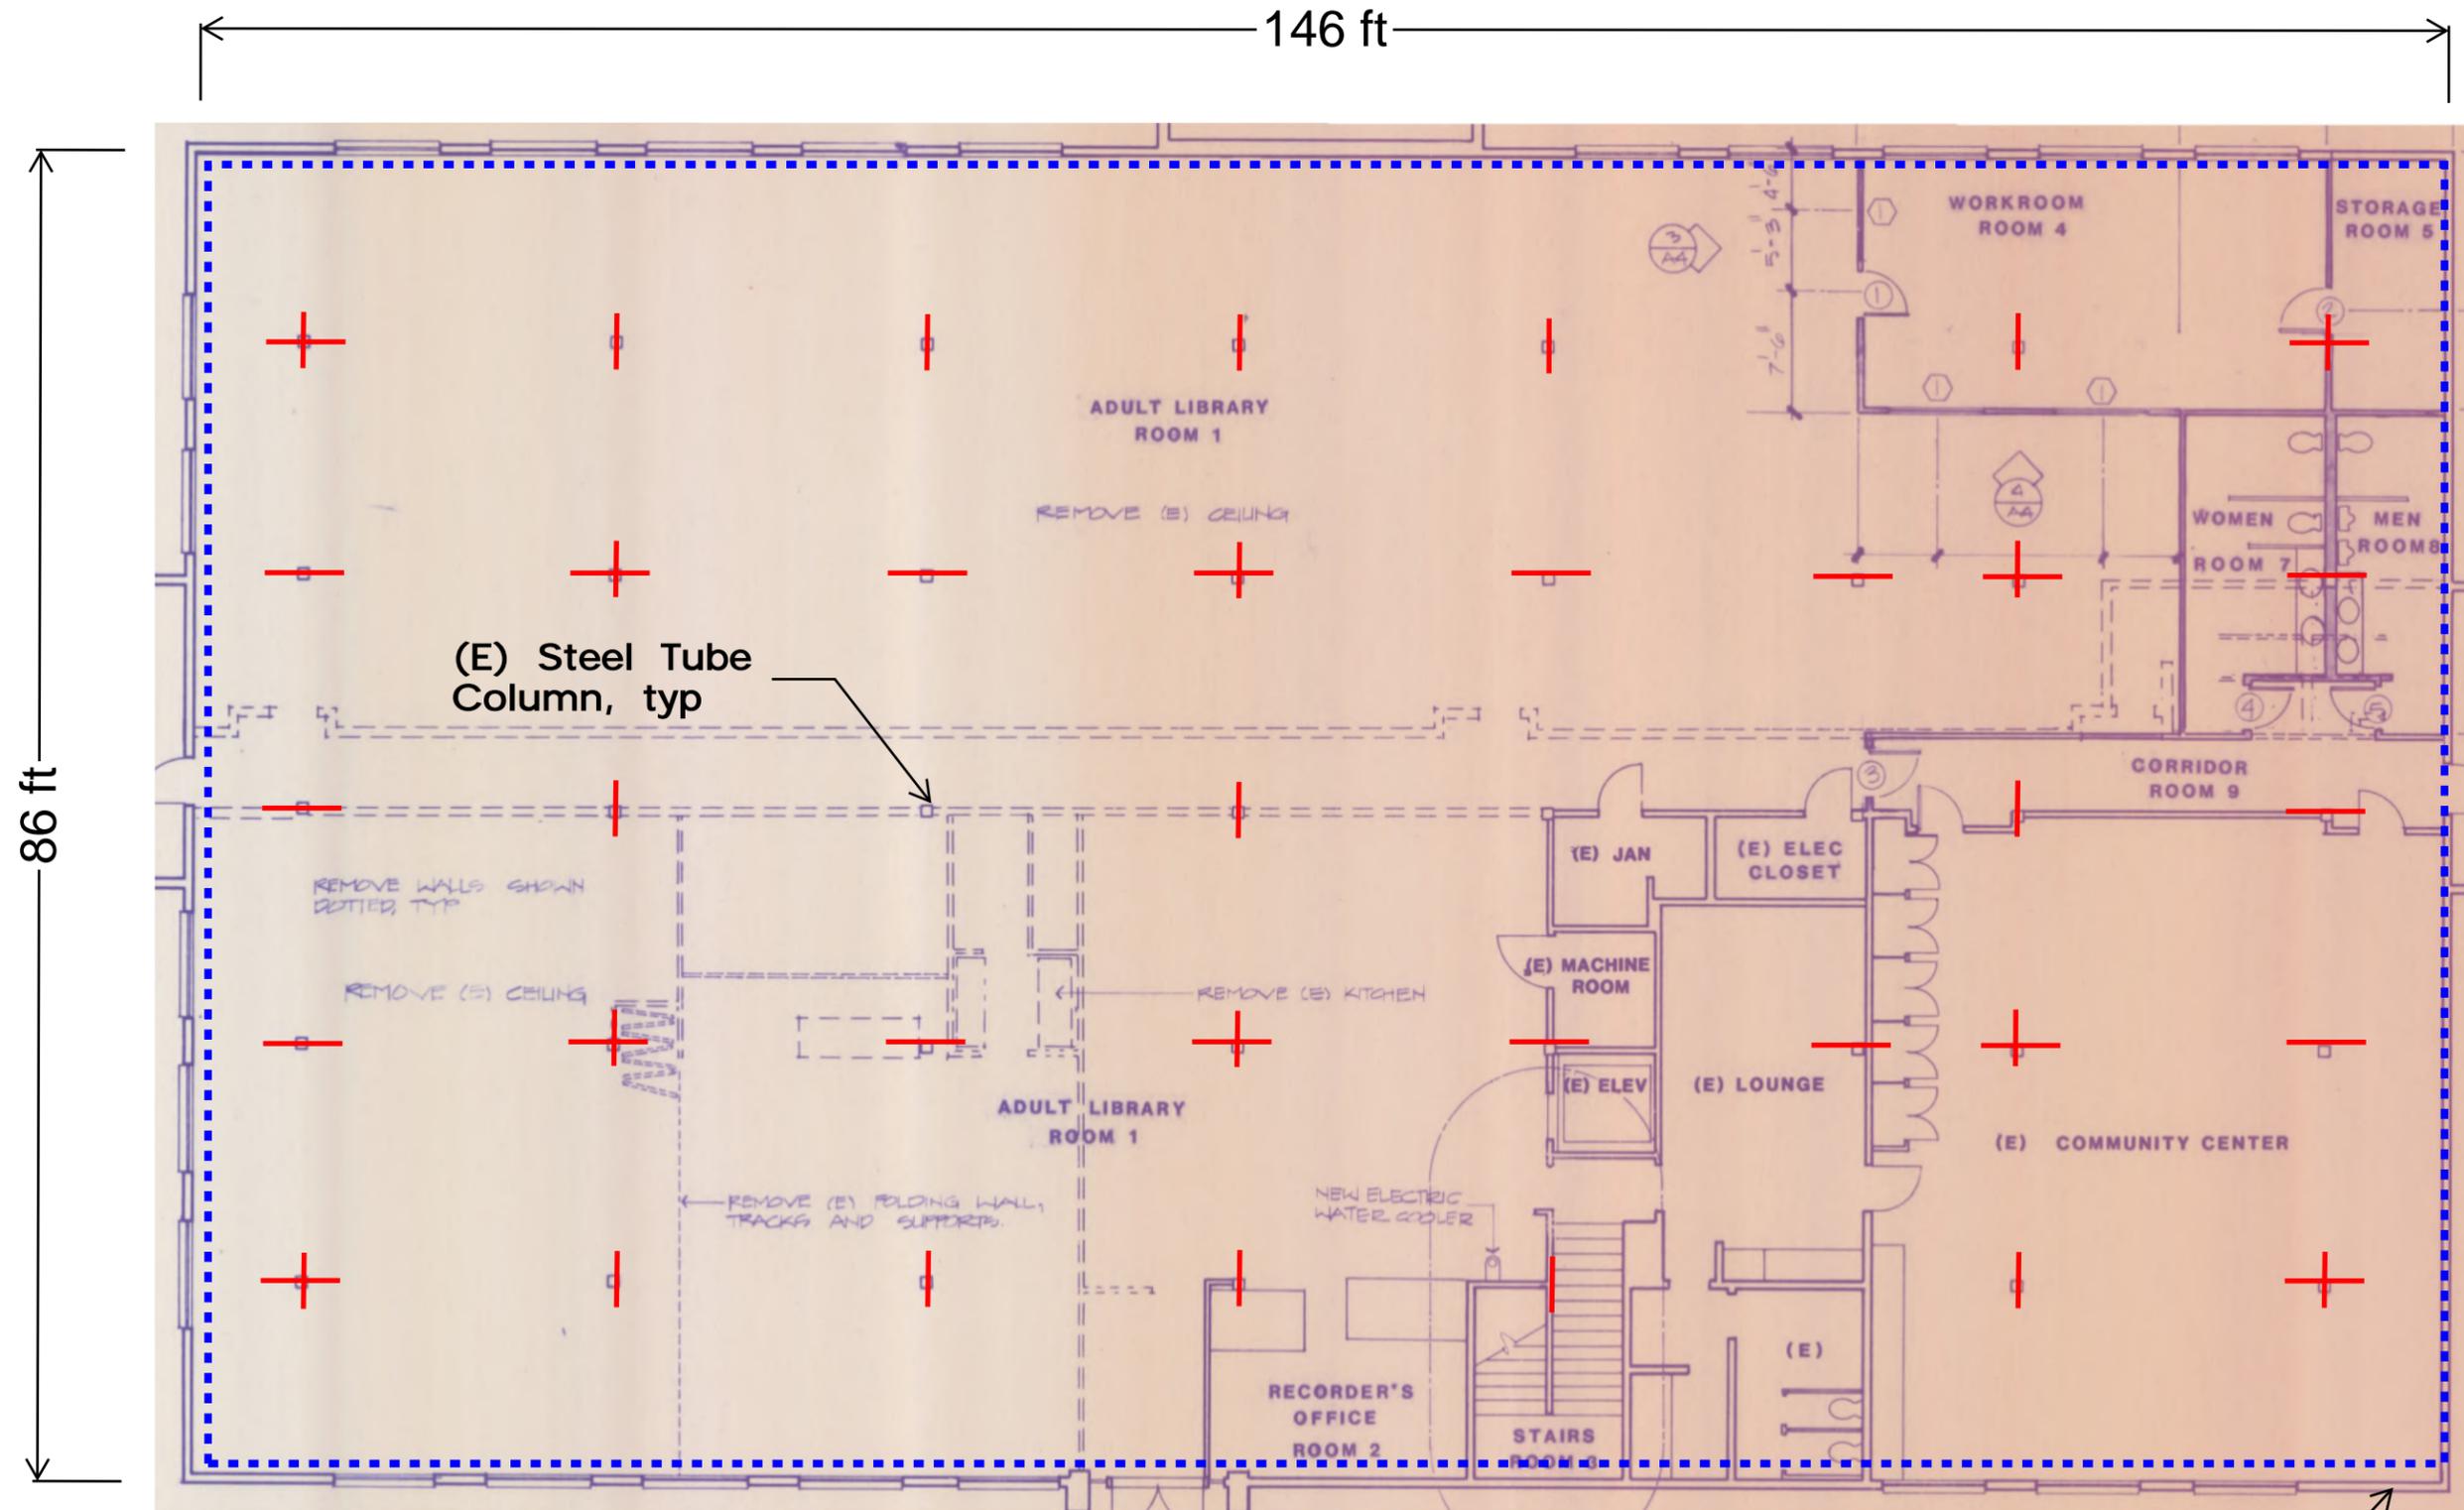
Second Floor Plan

7. At second floor level, building cross-ties are inadequate for transferring out-of-plane masonry wall loads into the floor diaphragm. Addition of new horizontal steel straps or steel rods with holdowns is required at beam splice locations (typically at columns).

3. At second floor level, provide building cross-ties by adding new horizontal steel straps or steel rods with holdowns at beam splice locations (typically at columns). [See Deficiency 7 above].

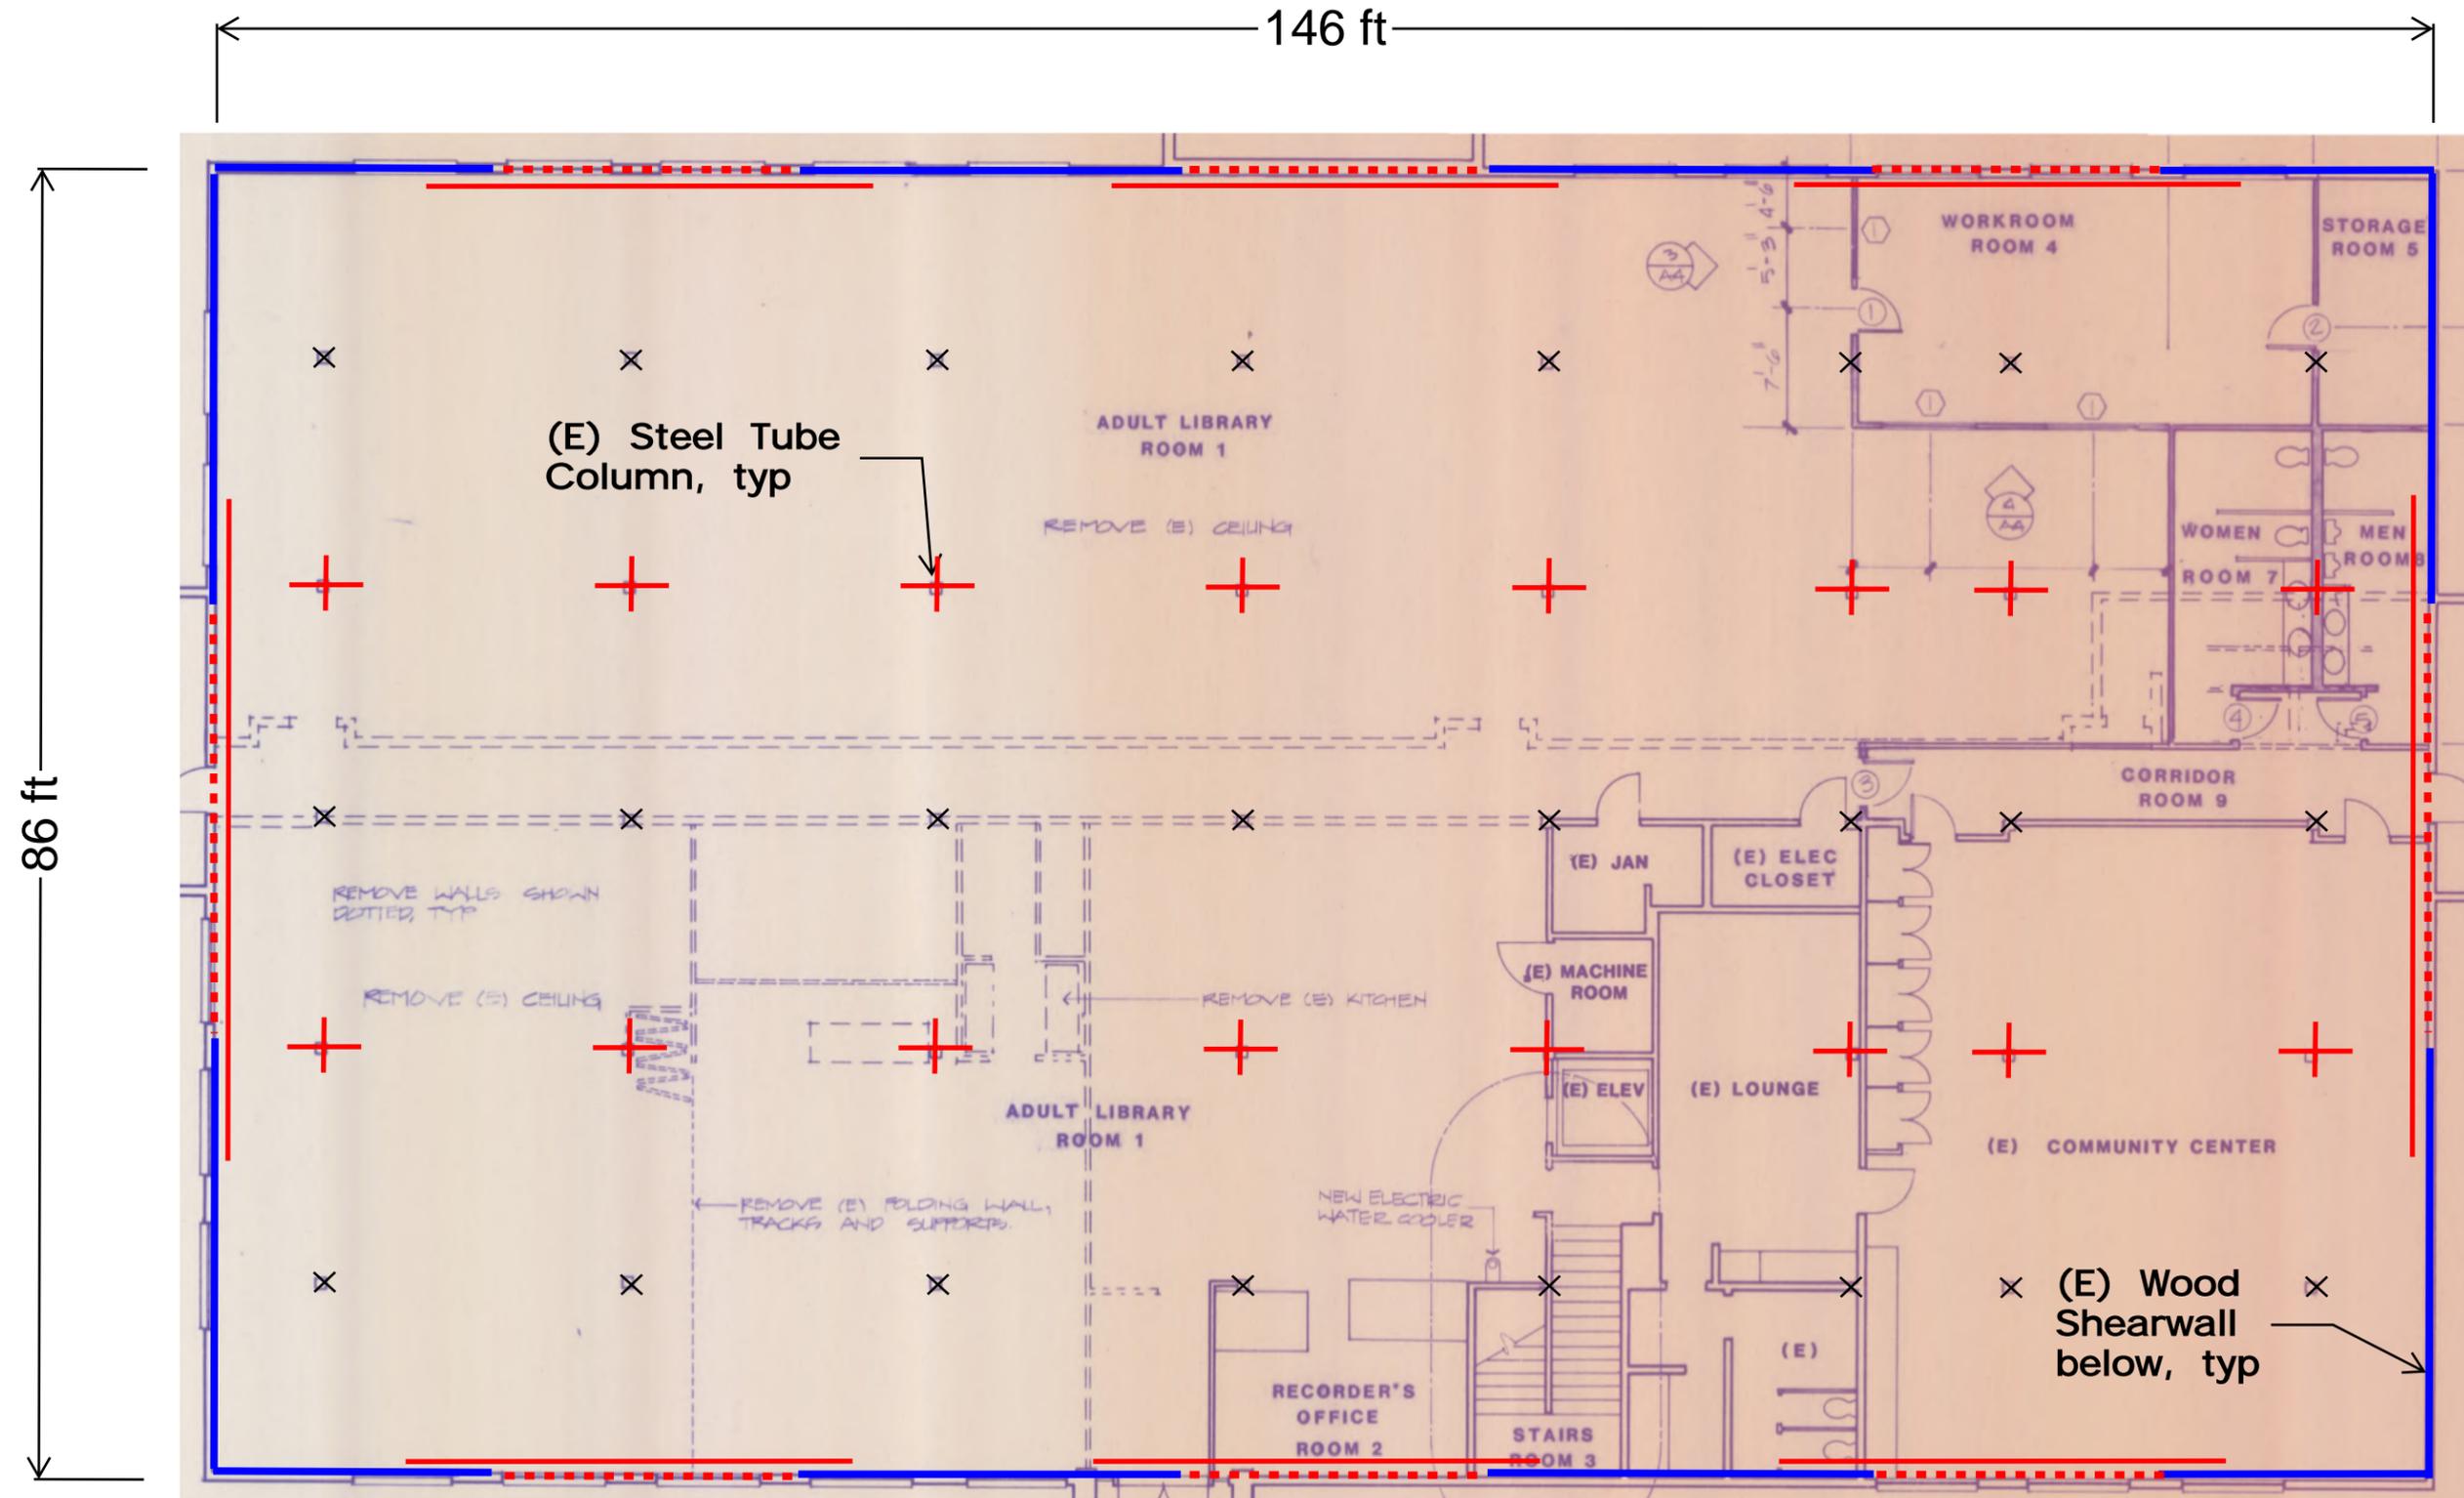
Roof Plan

2. At roof level, building cross-ties are inadequate for transferring out-of-plane wall loads into the roof diaphragm. Addition of new horizontal steel straps or steel rods with holdowns is required at beam splice locations (typically at columns).

3. At roof level, collectors along shearwall lines are inadequate for transferring the diaphragm load to the shearwalls. Addition of new steel straps with blocking between joists is required.

1. At roof level, provide building cross-ties by adding new horizontal steel straps at beam splice locations (typically at columns). These straps will be installed over the roof plywood sheathing, directly above the beams below. [See Deficiency 2 above].
2. At roof level, provide new collectors along shearwall lines by adding new steel straps over plywood sheathing, with new blocking between the joists. [See Deficiency 3 above].
